A CASE STUDY OF DAMAGE EFFECTS TO RESIDENTIAL BUILDINGS CAUSED BY VIBRATORY COMPACTION EQUIPMENT

This paper presents the findings into a study of vibration magnitude versus potential damage caused by vibratory compaction equipment at two residential properties located in South Australia. The two residential properties under investigation are classified as ‘Contributory’ in the local Historic Conservation Policy Area by Council and were constructed between the late 1800’s and early 1900’s. Vibratory compaction equipment was operated near to the properties at varying distances and machine settings with the primary objective to relate the measured vibration magnitude to cosmetic or structural damage, and to compare the results to the German Standard DIN 4150-3, 1999, *Structural vibration – Part 3: Effects of vibration on structures*. The secondary objective was to relate the measured vibration magnitude to subjective human perception and other observed ancillary effects to assist with community consultation activities that occur as part of major infrastructure projects. The results from the two objectives are presented and discussed in this paper.

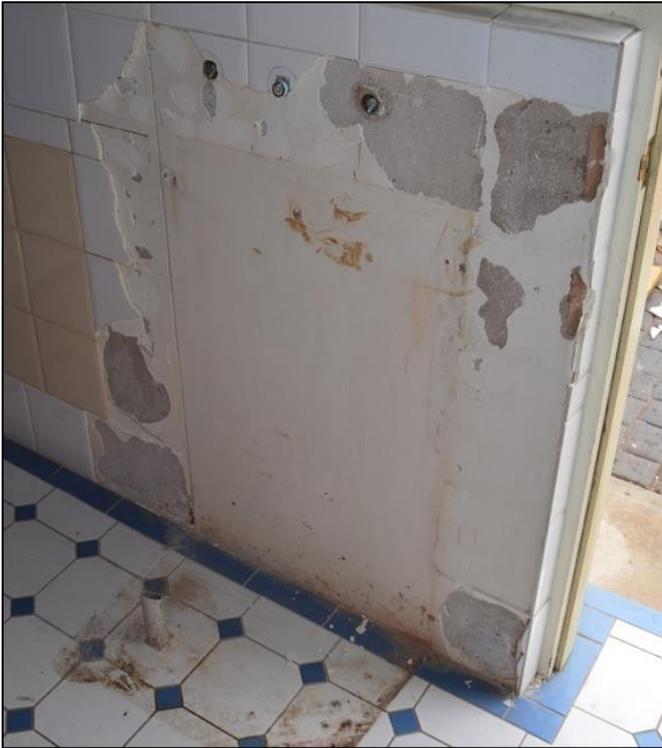
- in the rear laundry, minor plaster flakes were seen on the floor (Figure 3)
- at the front corner of the building (southern corner), a brick had fallen from the already damaged corner (Figure 4)

Figure 3. Damage with small flakes of plaster fallen from wall (already damaged by demolition works)

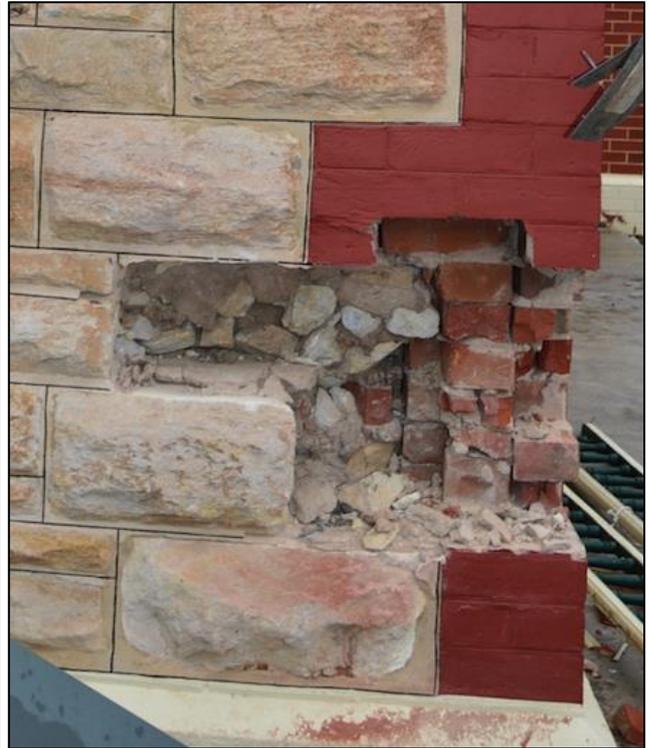
Figure 4. Damage with brick section fallen (already damaged by previous demolition)

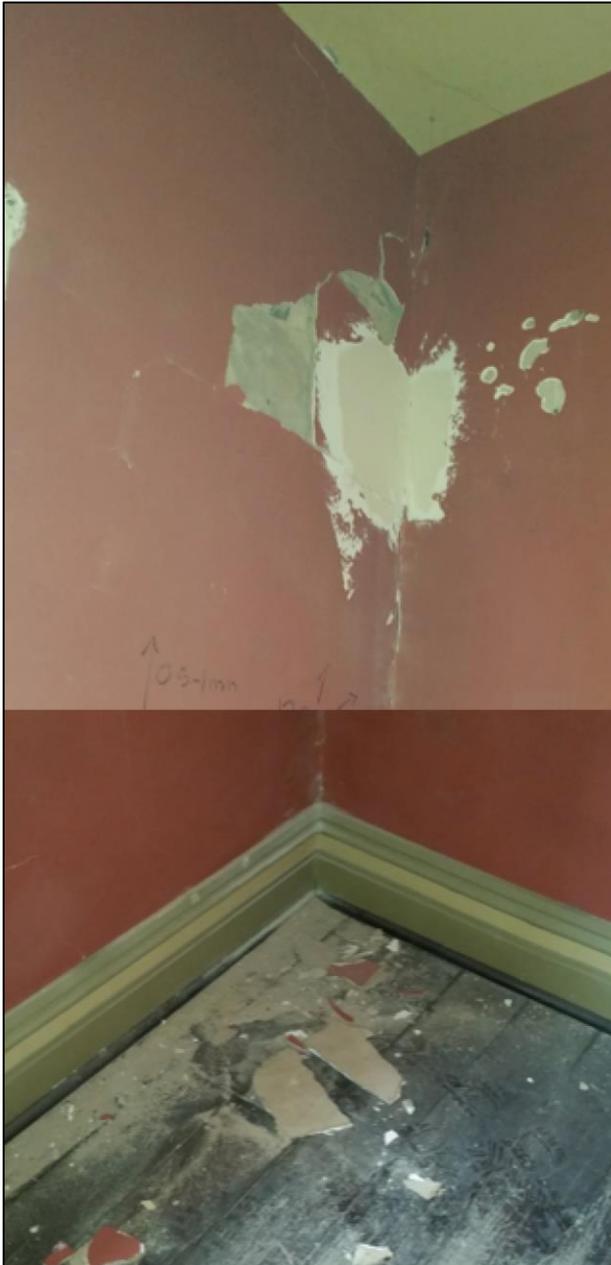
- An opening formed in the masonry wall on the eastern side of the out-house with bricks falling from the top section of the wall.
- A pre-existing crack below the window on the eastern facade continued to propagate and widen.
- Cracks formed on the inside corners of a room with audible ‘cracking’ type sound as the vibration level increased followed by a section of delaminated plaster falling from high up the internal wall closest to the roller location.

Figure 7. Cracked plaster (wall) and floor debris.

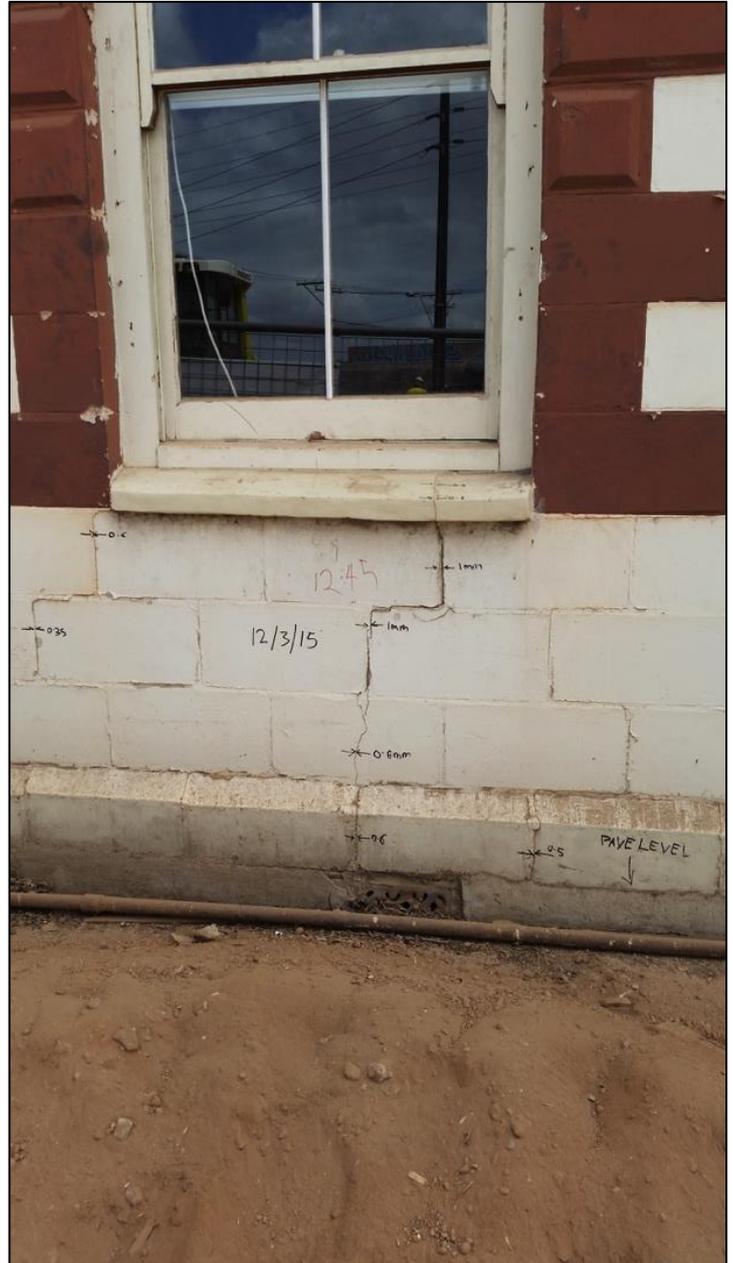
Figure 8. Crack observed below windowsill increased in size.
