FIFTH INTERNATIONAL CONGRESS ON SOUND AND VIBRATION

THE CASE OF THE VIBRATING SUPERFRACTIONATOR

Adolf E. Blach
Concordia University
Montreal, Canada

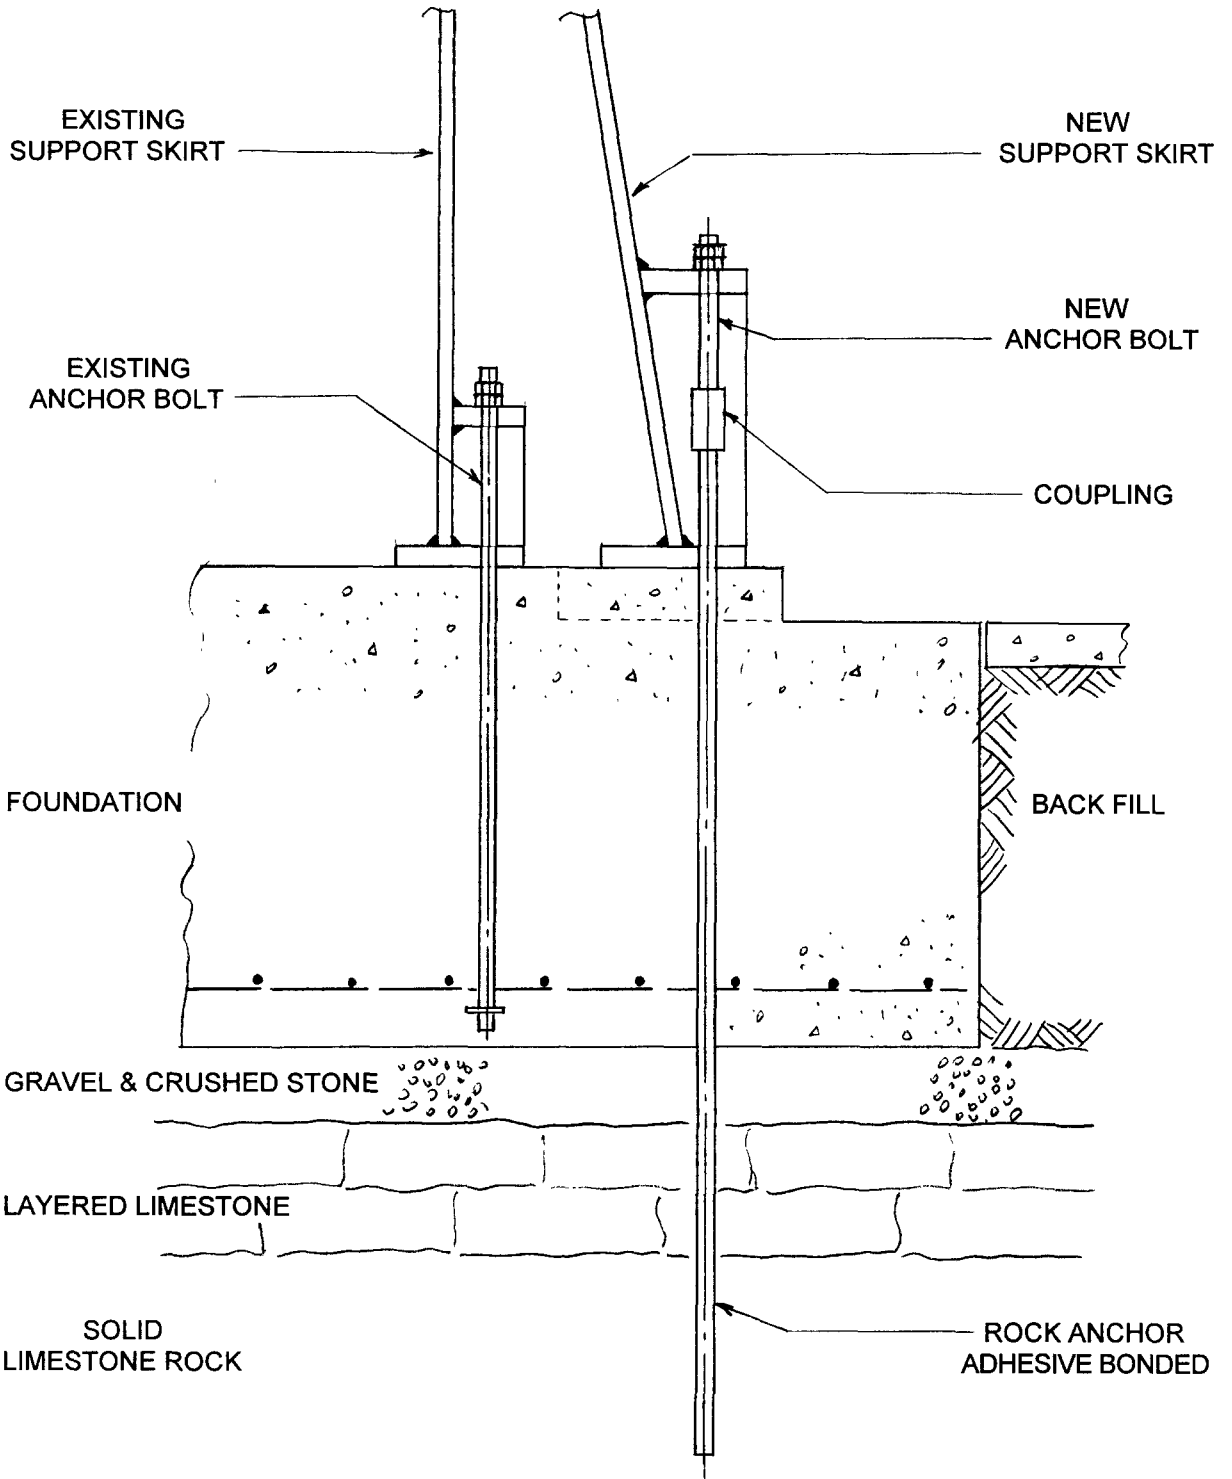
Fig. 2, Rock Anchor Installation

A lucky circumstance aided in finding a reasonable solution for the foundation repair. The original foundation was built on a bed of crushed stone spread over a bed of layered lime stone, only 300 mm below the bottom of the base slab. Test borings conducted around the tower foundation showed that solid rock was only 1.2 to 1.5 m below the top of the rock stratum. Thus it was decided that rock anchors should be used and connected to the new anchor bolts of the tower. This arrangement is shown in Figure 2.

36 holes for the rock anchors were drilled outside the tower pedestal, through the existing octagonal foundation, through the layered lime stone shale and a minimum of 1.5 m into the solid rock formation. Then 36 rock anchors of 50.8 mm (2") diameter were inserted in the drilled holes and adhesively bonded to the rock. The top of the anchors was cut about 300 mm (12") above the foundation and couplings were installed on the anchors.
