Improvement effect of the infrasound and vibration due to repair of the bridge

Saiji FUKADA¹; Yoshinori KANEISHI²; Hirokazu HAMA³; Hiroyuki OKADA⁴

ABSTRACT

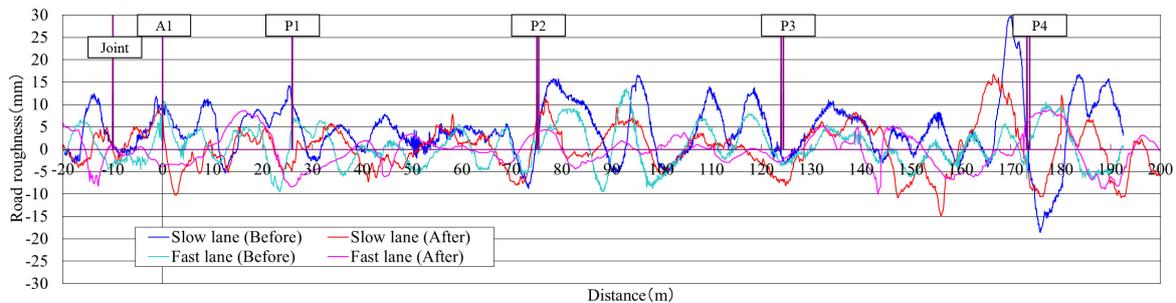
(a) Eastbound bridge

To compare the road roughness of the pavement before and after repair, Figs. 3 (a) and (b) show the road roughness of the pavement in each lane on the eastbound and westbound bridges, respectively. Bad road roughness is clearly observed in the eastbound (P2–P3) and westbound (P1–P2) bridges before repair, and it is reduced after repair.

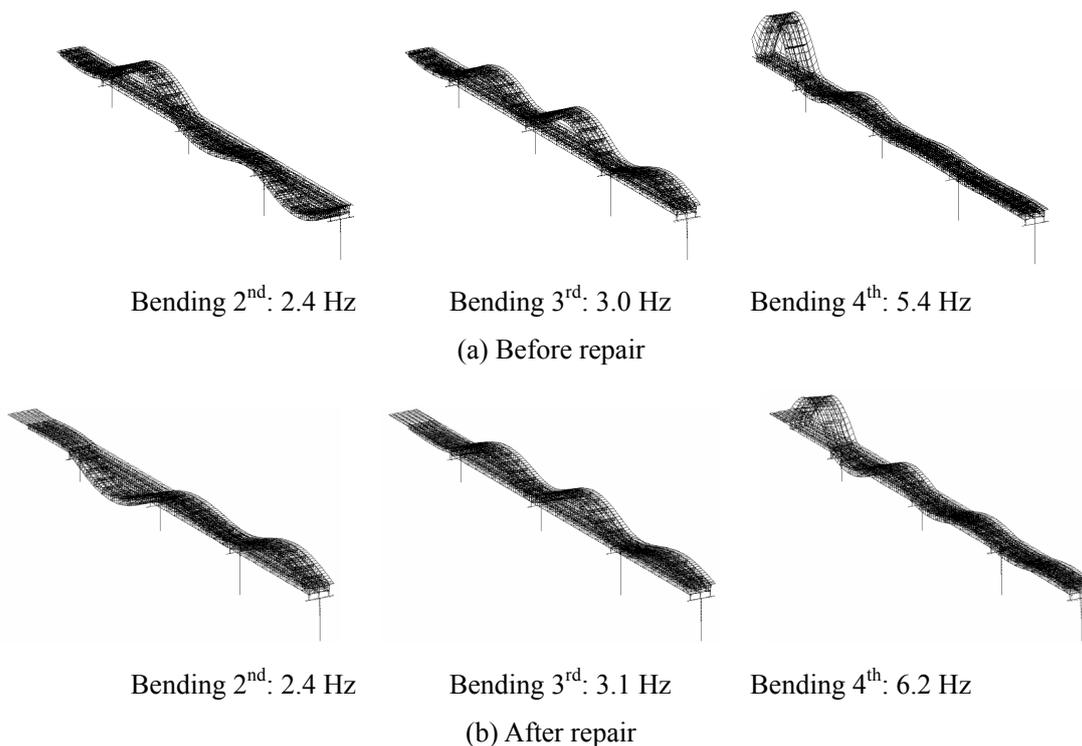
Figure 4 – Vibration modes (Eastbound bridge)

To compare the vibration characteristics of each bridge before and after repair, eigenvalue analysis was carried out using a finite element (FE) model. Figures 4 and 5 show the results of the vibration modes of the eastbound and westbound bridges, respectively.

A comparison of the frequencies before and after repair for the same vibration mode showed little change. These bridges show many similar vibration modes at frequencies of 2–5 Hz. Bending vibration modes with the same phase in each span of the westbound bridge at a frequency of 2.5–4.0 Hz clearly affect Houses A and B.

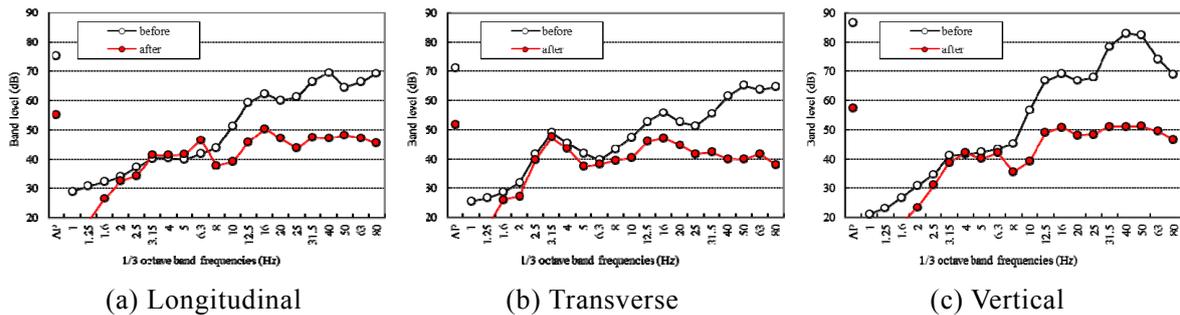
Figure 6 – Abutment A1 (Eastbound bridge)

Figures 6 and 7 show the results of the A1 abutment in the eastbound and westbound bridges, respectively. Trucks approach from the A1 abutment of the eastbound bridge. Because the extended deck method was applied at this A1 abutment, frequencies of 10–80 Hz caused by the trucks’ tire spring vibration at the A1 joint decreased greatly. On the other hand, at the A1 abutment of the westbound bridge, the extended deck method had a small effect because this abutment was not the approach side. Figures 8 and 9 show the results of the P1 pier in the eastbound and westbound bridges, respectively. All frequencies in the eastbound bridge reduced after repair. In contrast, frequencies of 10–80 Hz decreased greatly in the westbound bridge. Figures 10 and 11 show the outsides of Houses A and B on the ground, respectively. Houses A and B are affected by frequencies of 3.15–4.0 Hz and 10–20 Hz from the westbound and eastbound bridges. Repair showed a pronounced effect for frequencies of 10–20 Hz, whereas other frequencies decreased slightly. Repair showed greater effect at House B than at House A.

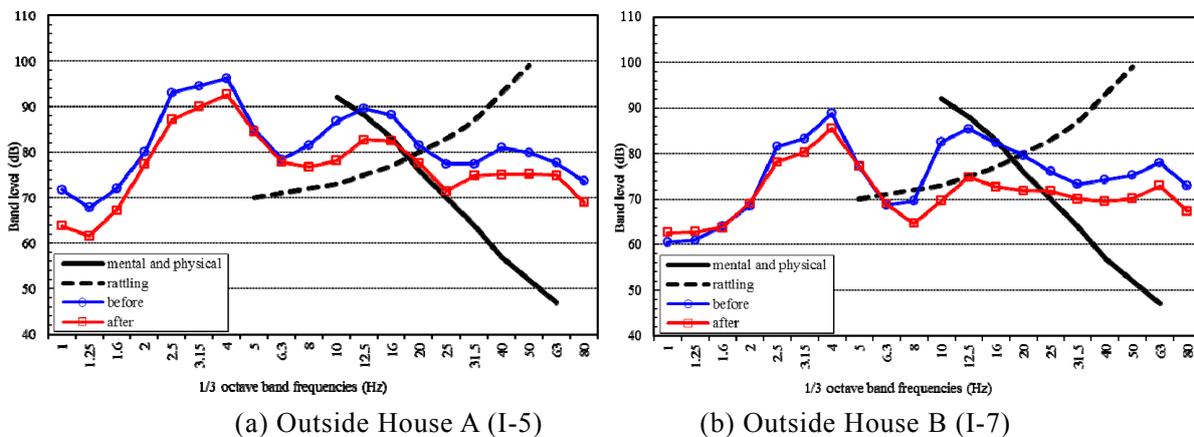
Figure 12 – Infrasound (band level) of every 1/3 octave band frequency before and after repair

Figures 12 (a) and (b) show the infrasound (band level) of every 1/3 octave band frequency at the outside of Houses A (I-5) and B (I-7), respectively. Though Houses A and B are affected by frequencies of 2.5–4.0 and 12.5 Hz, each peak band level is decreased. In particular, the peak band level at a frequency of 12.5 Hz for House B is below the dotted line.
