Assessment of masonry bell tower response to bell ringing using operational modal analysis and numerical modelling

The authors carried out an investigation into the dynamic response of a bell tower. The main focus of this study was to investigate the mechanism behind the perceived high vibration response during bell ringing as well as to provide an assessment of the severity of vibration response with respect to risk of damage to the structure. A combination of operational modal analysis techniques (including a non-contact measurement option) and finite element modelling was used to analyse the dynamic response of the structure. This paper discusses the measurement and modelling techniques implemented in order to assess the effect of bell ringing to the tower structure as well as retrofit and monitoring strategies proposed in order to manage and monitor the motion of the tower for improved safety.

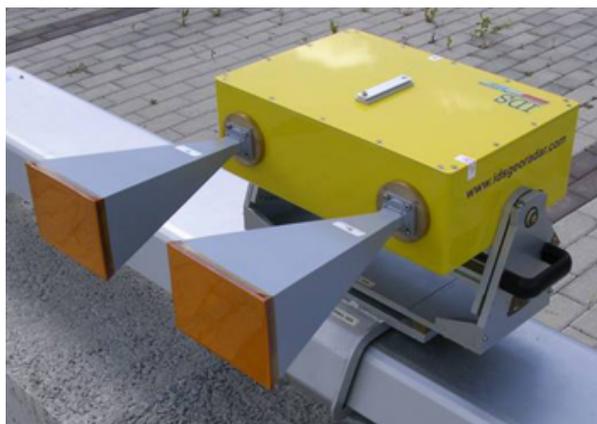
Figure 9. IBIS-S displacement measurement system

The maximum displacement level at the top of the tower due to vibration was extrapolated to be just below 2 mm (peak). This result correlates well with the highest displacement measured with the remote (IBIS-S) dynamic displacement measurement system (Figure 9).

The IBIS-S interferometric radar based displacement measurement system (Figure 9) was set up across the street from the bell tower on the top level of a two storey car park in order to avoid interference from other moving obstacles such as trees and vehicles. The system was directed at the bell tower (ensuring that the entire tower fit within the field of view of the system). IBIS-S displacement measurements (Figure 10 shows a sample displacement time history) were undertaken simultaneously to the accelerometer measurements (Table 2).

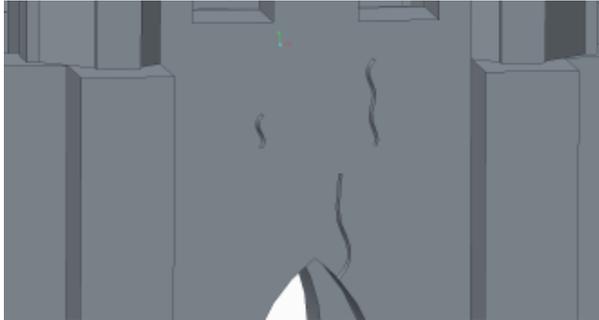
Figure 13. View of FE model showing simulated cracks

The results of a photogrammetric survey (Figure 12) were used to simulate significant existing cracks in the FE model. The measured cracks were modelled physically (Figure 13) where they were found to be locally potentially significant, and in other areas they were modelled globally by incorporating them into the FE model by way of changed overall homogenous material properties.
