**Acoustics 2019**

# Static insertion loss, transmission loss and noise reduction testing of an acoustic louvre

Michael Hayne (1), Dexter Tan (2), Richard Devereux (3) and David J. Mee (2)

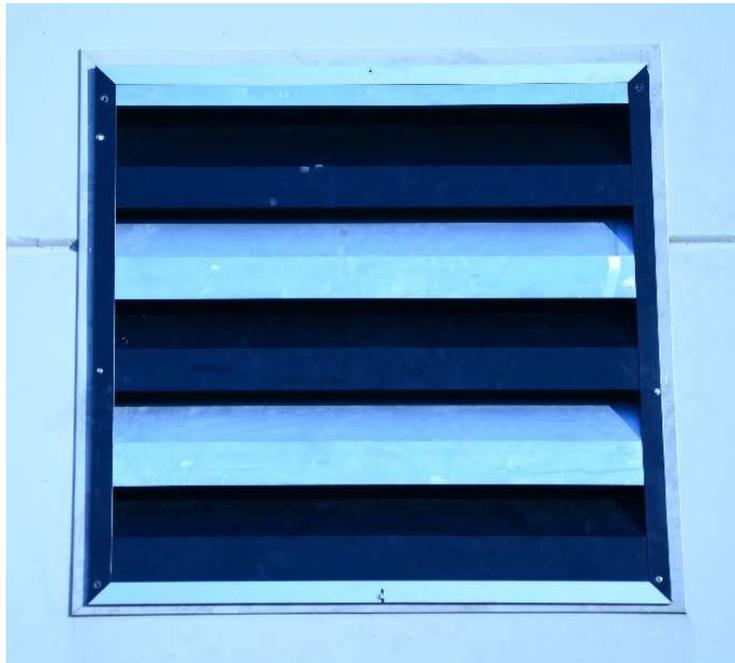
Figure 1: Photo of the louvre used in the testing

The test sample consisted of a single stage acoustic louvre as shown in Figure 1. The black and silver colouring of the louvre has no significance beyond differentiating the louvre from Acran's commercially available louvres. The louvre was sized to be 1.0 m x 1.0 m to allow it to be rotated in the test openings. A structural frame was used to hold five aerodynamically-shaped blades. Each blade had a smooth metal finish on the top surface and a perforated surface on the underside to expose the sound-absorbing in-fill.

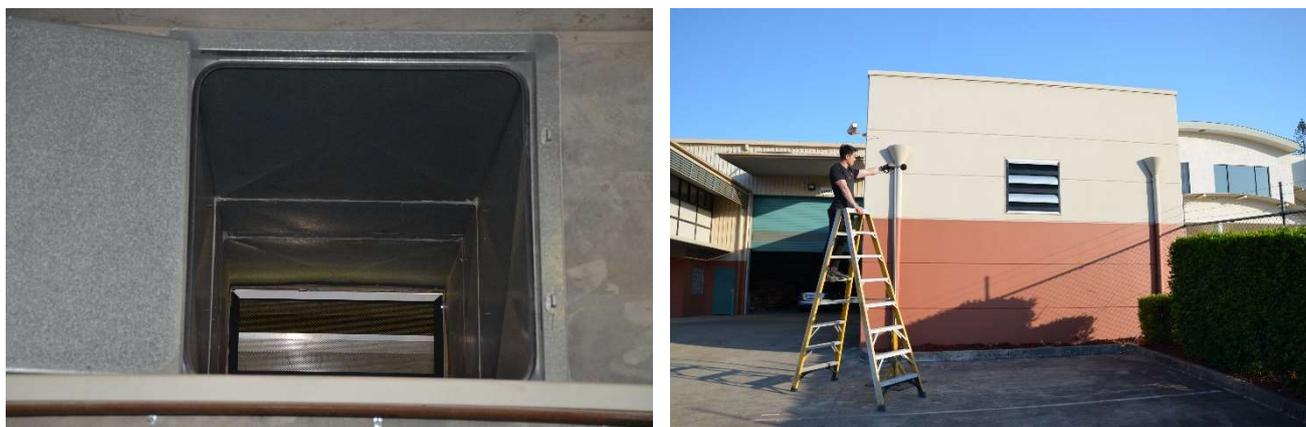
Figure 7: Metal duct and flush mounted louvre flush with the wall at end of duct

The static insertion loss results are compared in Figures 8, 9, 10 and 11. In Figure 8 the test arrangement was as shown in Figure 2, while in Figure 10 the louvre was mounted flush at the end of an unlined 2.5 m long metal duct as shown in Figure 7. Due to the presence of a hedge and security fence, the insertion loss was only able to be measured between 30° and 105° for the louvre at the end of the metal duct.
