# Acoustics laboratory fire at the University of Sydney

Ken Stewart, Densil Cabrera and Fergus Fricke

Faculty of Architecture, University of Sydney, NSW 2006, Australia

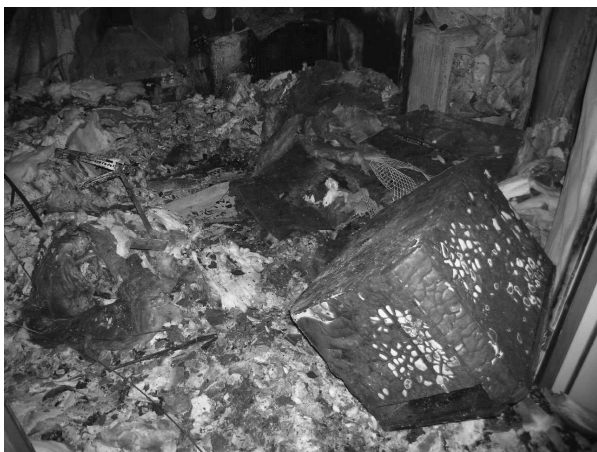
**Figure 3.** Anechoic Room after the fire

melted in the fire, so only small pieces of it were found afterwards. Various cables, including twelve loudspeaker leads, were fed into the room through small ports in the wall, and we understand that these were initially mistaken for high tension electrical supply cables by those investigating the fire (and considered to be a possible cause of the fire). The room also had a compressed air supply which, after the rubber hose melted, fed the flames with oxygen. Upon hearing the sound of this escaping gas, the fire fighters withdrew until the supply was stopped. The Fire Brigade investigation of the cause of the fire was inconclusive. It seems likely that the unusual nature of the room caused some confusion in the initial assessment, which could not be resolved later because material from the room had been removed. Figure 3 shows the anechoic room after the fire. The solid object front right is the charred remains of the subwoofer cabinet.

No matter where its location within the laboratory (even in the dome at the far end of the laboratory), only equipment sealed in airtight cases was saved from the hot corrosive smoke. Loudspeakers throughout the laboratory were damaged or destroyed, sometimes through the melting of their suspension, or else through corrosion. Most of the sensitive electronic equipment throughout the lab was damaged. About half of the microphones were damaged. The estimate for reinstatement (currently at AU\$2.7M) is dominated by the equipment loss.

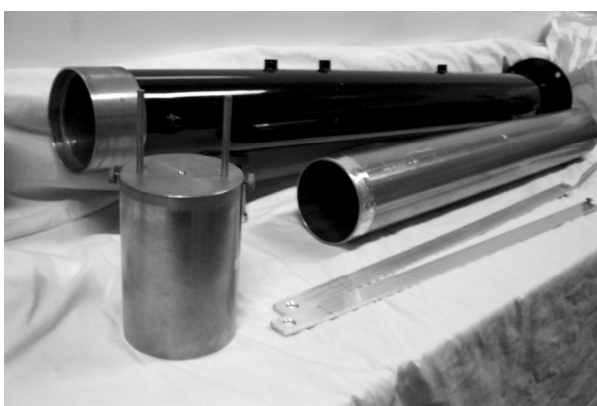
**Figure 4.** The modified standing wave tube (rear) for transfer function measurements of impedance, with the extension tube and retaining strap extensions in front.

A case in point here is the standing wave apparatus or impedance tube system that was used by Jingfeng Xu in his research papers on anechoic room linings referred to in this paper. For initial data and final validation, his measurements required looking at various acoustic materials combined in systems and these were sometimes far too thick to mount in the off-the-shelf test apparatus. An extension pipe and holding brackets were manufactured in the faculty's on-site technical service centre (ATSC). This allowed for measurements on layered materials up to 800 mm thick. There are two usual means of measuring absorption coefficient of porous absorbers, the standing wave method (ISO 10534-1:1996) and the two microphone intensity method (ISO 10534-2:1998). We had three separate sets of equipment allowing us to use the first of these methods. Therefore we adapted one of our standing wave tubes to accept the two microphones and deploy it in conjunction with a suitably programmed computer controlled analyser and appropriate microphones to be able to confidently use this method as well. Figure 4 shows the modified tube and the extension pipe.

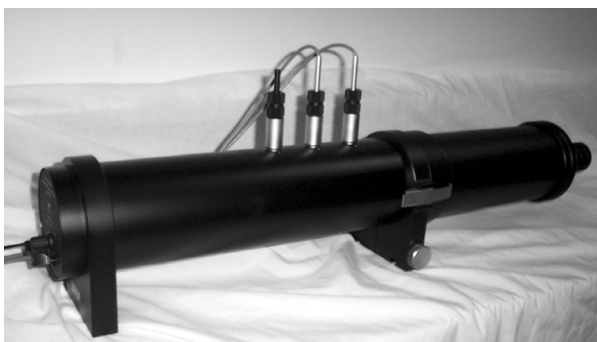
**Figure 5.** Impedance tube using the transfer function method.

The new system uses a computer controlled data acquisition unit with an inbuilt noise generator and the manufacturer's software package to run the system and organise the data and will be how we will obtain absorption coefficients of porous materials from now on. This device has the added advantage

of measuring a continuous transfer function. The length of this pipe can be increased in 200mm steps using extensions designed to allow for increased air gaps, but it is yet to be seen if this can be built up to allow for 800mm samples.
