# ACOUSTICS OF THE SYDNEY OPERA HOUSE CONCERT HALL

## Part Two: The Acoustician's Perspective

R. Lawrence Kirkegaard (1), Timothy E. Gulsrud (2), and Shimby McCreery (1)

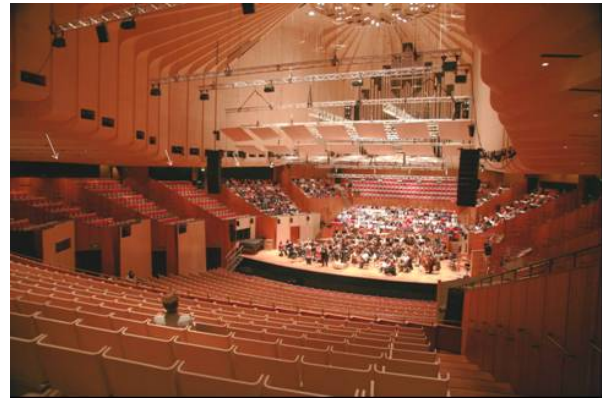
**Figure 1.** Photograph of the Concert Hall interior with acoustic trial elements in place

The acoustic trials included 4 primary elements: modifications to the stage canopy, modifications to the lower sidewall geometry around the platform and the stalls level, strategic placement of lightweight fabric at the sidewalls behind the boxes, and installation of an electronic architecture system.

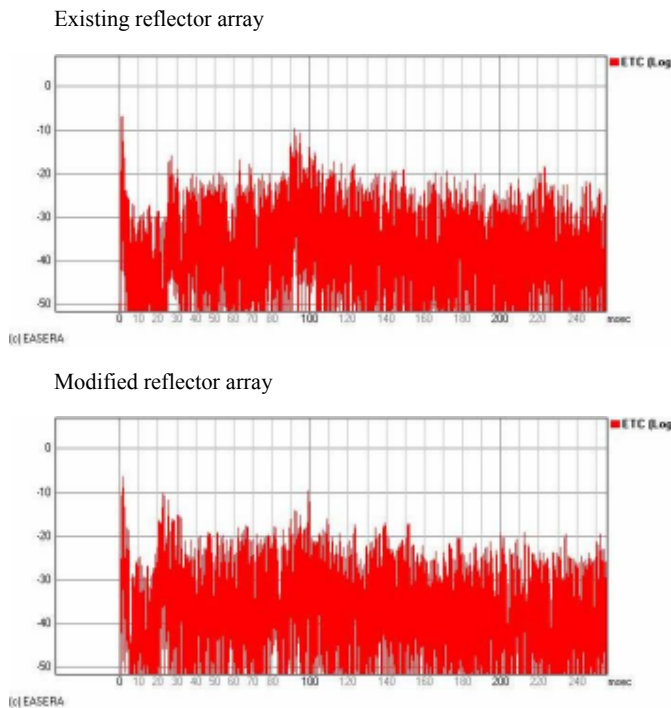
Figure 3 shows impulse responses measured before and after the canopy was reconfigured, with the source at a percussion position on the stage and the receiver at the conductor's position. The sound source used was a small directional loudspeaker (Meyer Sound MM-4XP) to simulate the directivity of musical instruments better than a standard dodecahedral loudspeaker. The loudspeaker was aimed slightly upward to study the overhead reflection structure. Measurements were made using an Earthworks QTC30 omnidirectional microphone and EASERA acoustic measurement software.

In Figure 3 note several strong reflections at approximately 90ms after the initial arrival of sound, corresponding to late

reflections from the crown and the ceiling immediately in front of the crown. These particular reflections are responsible for timing difficulties for percussion instruments heard downstage, especially at the Conductor's position. After the canopy was reconfigured the magnitude of this reflection was substantially lowered, as seen in Figure 4. This energy is visibly shifted closer to 25ms after the initial arrival of sound where it blends more smoothly with the rest of the room's reflections. This change represents a strong improvement in rhythmic clarity that can be directly attributed to the reconfiguration of the overhead canopy. This audible improvement was noted in conversations with the conductor between rehearsals. Members of the choir also cited an increased ability to hear other ensemble members. Members of the choir seated in the center terrace reported particularly significant improvements in the clarity of musical instruments which aided in their tuning and timing of vocals passages.

**Figure 3.** Impulse response showing overhead reflections at the conductor's position before and during the acoustic trials.

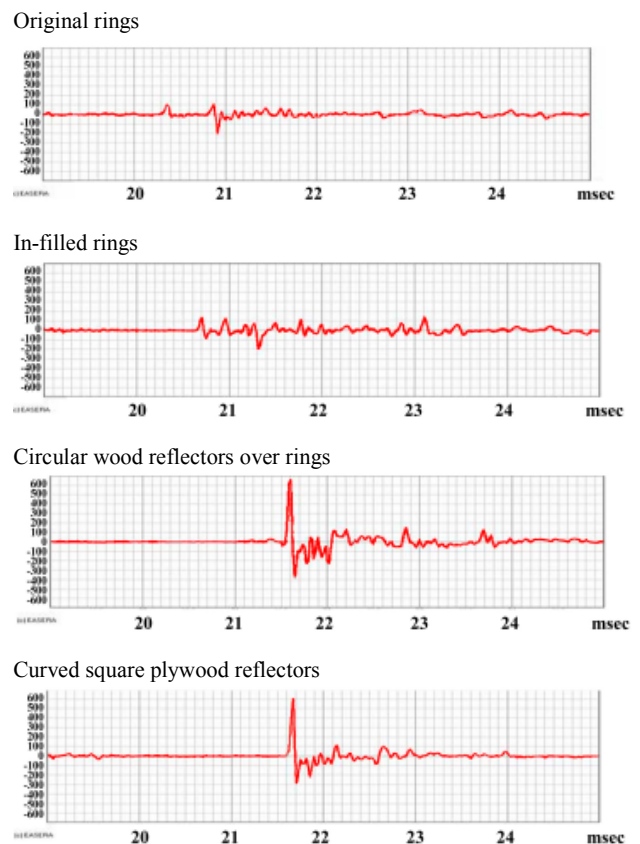
Figure 4 compares the reflection patterns for each reflector type. The comparison between the original and in-filled rings shows a modest increase in acoustic energy reflected to the platform when the rings were in-filled. Both the plywood coverings and the square plywood reflectors, however, provide substantially stronger reflections. The flatter plywood geometries also eliminate the "smeared" sequence of small reflections exhibited by the rings, resulting in a much more coherent and useful reflection for hearing other members of an ensemble across the stage. Not only is the level louder, but the acoustic integrity of sound coming from the overhead reflectors is preserved. Although the square plywood reflectors have a larger surface area, the magnitude of the reflection is slightly less than that from the circular plywood reflectors because the square panels are slightly bowed. This slight degree of reflection spreading is controlled and helps to blend the sound from adjacent reflectors to compensate for the gap between them, while avoiding excessive overlap. This bowing also helps to project appropriate amounts of sound into the house while retaining enough for onstage communication.

**Figure 4.** Comparison of reflection patterns from stage canopy reflectors. The vertical scale is linear pressure and the horizontal scale is time from 19 to 25 ms.

In order to evaluate potential improved reflector geometries, four types of reflectors were mocked up over the Concert Hall stage: the original rings, the rings in-filled with acrylic lenses, the rings covered at the underside by a flat circular wooden panel, and slightly bowed square plywood reflectors. Using the semi-directional loudspeaker described above together with an Audio Technica 835b shotgun microphone to discriminate against reflections from other room surfaces, we measured impulse responses for each type of reflector. The loudspeaker and microphone were aimed along the expected specular reflection path for the source-receiver configuration, and gain settings held constant to properly compare each reflector sample.

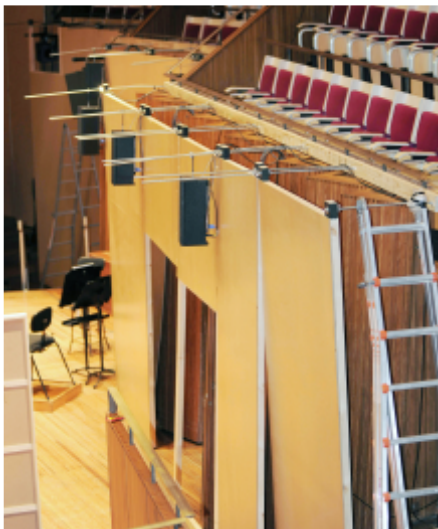
**Figure 5.** Photograph of adjustable sidewall panels erected for acoustic trials. Threaded rod supports at the tops of the panels allowed tilt adjustments in plan and section.

For the acoustic trials, sealed medium density fibreboard (MDF) panels were placed in front of the sawtooth walls. The MDF panels were designed to be adjustable to allow experimentation and optimization of wall angles. Over the course of the week, the orientation of the panels was optimized in plan and section. While noticeable to musicians onstage, the improvements from this modification were most significant in the stalls seating.

In the third configuration, the panel orientations were preserved in plan, but were tilted back to direct sound slightly upward into the space. This last configuration provided the best balance of useful undistorted reflections in the stalls and upper circle while controlling loudness. The tilted panels also improved listening conditions for the boxes by providing these locations with beneficial cross-room reflections.

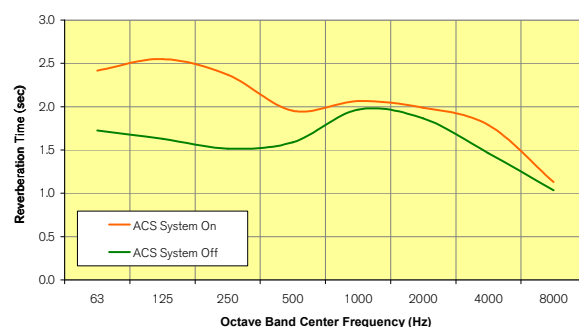
The ACS system provided much needed low frequency support without masking the natural acoustic sound or calling attention to itself. Figure 6 shows reverberation time measurements made in the fully occupied hall with the ACS system both off and on.

**Figure 6.** Reverberation time measurements made in the occupied hall with the ACS system on and off.

Figure 6 shows that the system substantially enhances low frequency energy in the room. For the acoustic trials the ACS system was tuned to create a natural RT curve for the Concert Hall, providing early reflection and reverberation support below approximately 500Hz. The slight dip visible in the orange curve at 500Hz was addressed by subsequent system tuning during the course of the week.

The reverberation time measurements were made with a Meyer Sound MM-4XP loudspeaker supplemented with a UMS-1P subwoofer to extend the low frequency response to the 63Hz octave band. This loudspeaker system has been found to give equivalent mid-frequency reverberation time results to the standard dodecahedral loudspeaker typically used for room acoustics measurements [5].

Measurements were made in the occupied hall following the procedure outlined in [5], in which a series of logarithmic sine sweeps was played and captured with EASERA to measure room impulse responses. The system enabled simultaneous measurement of 12 channels, allowing data at several audience and stage positions to be gathered with one set of sweeps, which is an important consideration for occupied measurements that require cooperation of the audience.

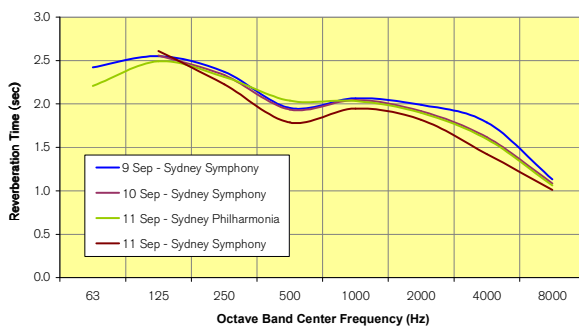
It is worth noting that the system will always reproduce the same acoustic response within the room as if it were part of the permanent architecture. Figure 7 shows the reverberation time curves for the system on during 4 different concerts. The small differences in the reverberation curves can be directly attributed to the differences in occupancy and crowd distribution for the various concerts, as opposed to the ACS system.

**Figure 7.** Reverberation time measurements made in the occupied hall with the ACS system in operation during 4 different concerts.

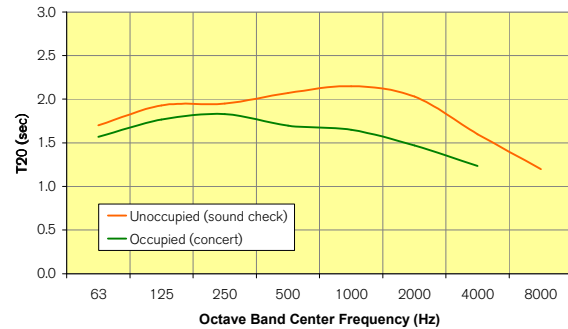
During the concert (Ben Folds, 6Sep09) we used EASERA SysTune software to measure reverberation times in the hall, using program material from the PA system as a sound source. This approach allowed measurements to be made continually through the concert without any disruption. A direct feed from the mixing desk served as a reference signal, and measurements were limited to one microphone position located at the front of house mix position. Average results for reverberation times measured during the course of the concert, and also in the unoccupied hall during a sound check prior to the concert, are shown in Figure 8.

**Figure 8.** Reverberation time measurements made in the hall during an amplified event.
