## Curve Squeal: Causes, Treatments and Results

<sup>1</sup>Transport for New South Wales Freight & Regional Development, Australia

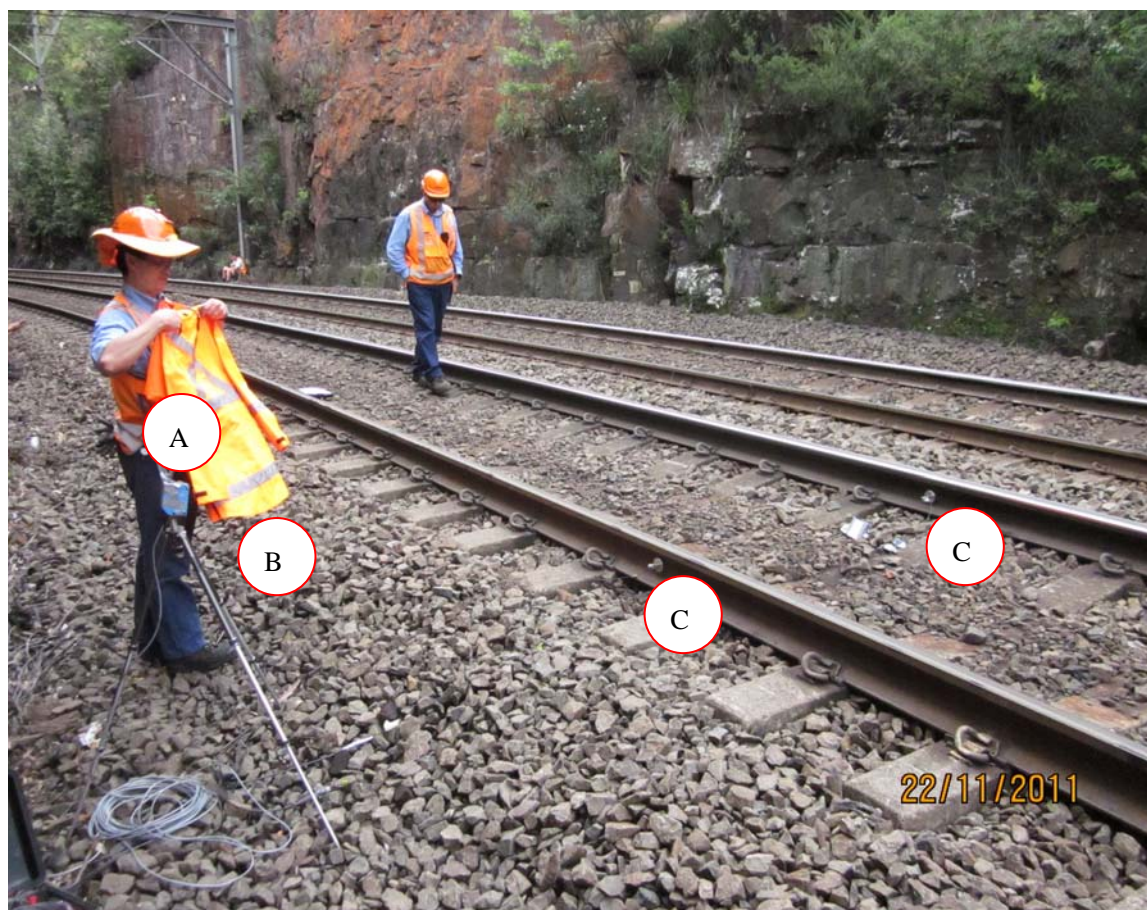
Figure 1 – Measurement system to identify which wheel is squealing – microphone (A), optical switch used as a wheel sensor (B) and rail mounted accelerometers (C)

This basic approach can be further developed by the addition of an accelerometer mounted on the underside of each rail. By comparing the vibration levels from each squealing wheel, a difference of at least 10dB has proven a reliable differentiator, the rail on which squeal is occurring can be identified. This simple addition has highlighted stark differences between the squeal “mechanism” at different sites on the network, with the full spectrum from almost all squeal occurring on the LOW rail side to almost all squeal occurring on the HIGH rail side, being observed at different sites.

This measurement system is shown in Figure 1.

A word of caution regarding the accelerometers. On electrified lines, it is important to isolate the accelerometers from the rails – standard accelerometer case isolation is typically not sufficient as break-down voltages of >1kV are often required. A disk of 3mm Perspex between the accelerometer and the rail will do the job. In addition, the selection of accelerometers must consider the extreme rail accelerations that can occur under squealing wheels. We have measured (briefly) accelerations in

excess of 1500g at frequencies >10kHz which caused the demise of accelerometers. This can be mitigated through mechanical filtering (such as a thin rubber element between the accelerometer and the rail, or a magnet mount) or preferably by selecting accelerometers with an appropriate shock rating.

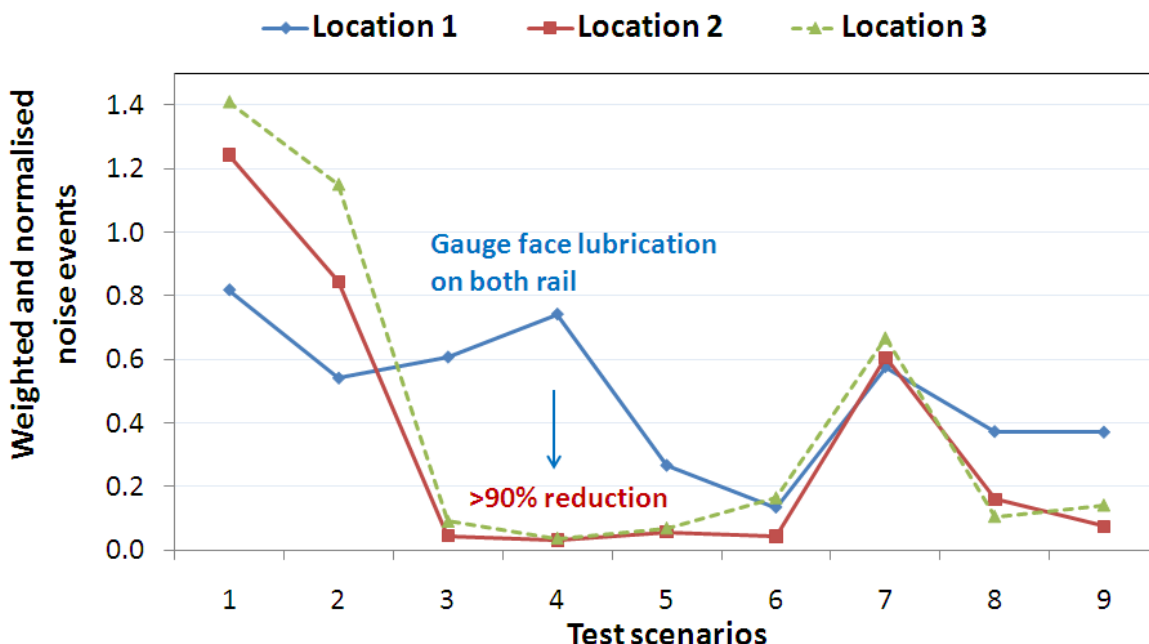
Figure 2 – Summary of the results of the 2012 friction management trial at Beecroft

In 2012, RailCorp (the precursor to TfNSW) undertook an extensive study into the effectiveness of gauge face lubrication and top-of-rail-friction-modification for the purposes of noise mitigation. These trials involved in-service measurements of noise and vibration over more than six months at three locations around a 300m radius curve. Treatments were applied in between the first and second measurement location. The test and results are described in detail in (3), and summarized in Figure 2. The trial concluded that gauge face lubrication when applied to both rails delivered the greatest mitigation in squeal noise. The study further identified squeal noise being generated under four distinct wheel/rail interaction conditions – top of the HIGH rail and LOW rail, which were the traditionally accepted mechanisms for squeal as found in the literature, but also at the gauge corner of the HIGH rail and LOW rail, which was counter to accepted wisdom. Indeed, the majority of squeal at this curve occurred under gauge corner contact conditions on the HIGH rail, and hence was effectively mitigated by lubricating this section of the rail.

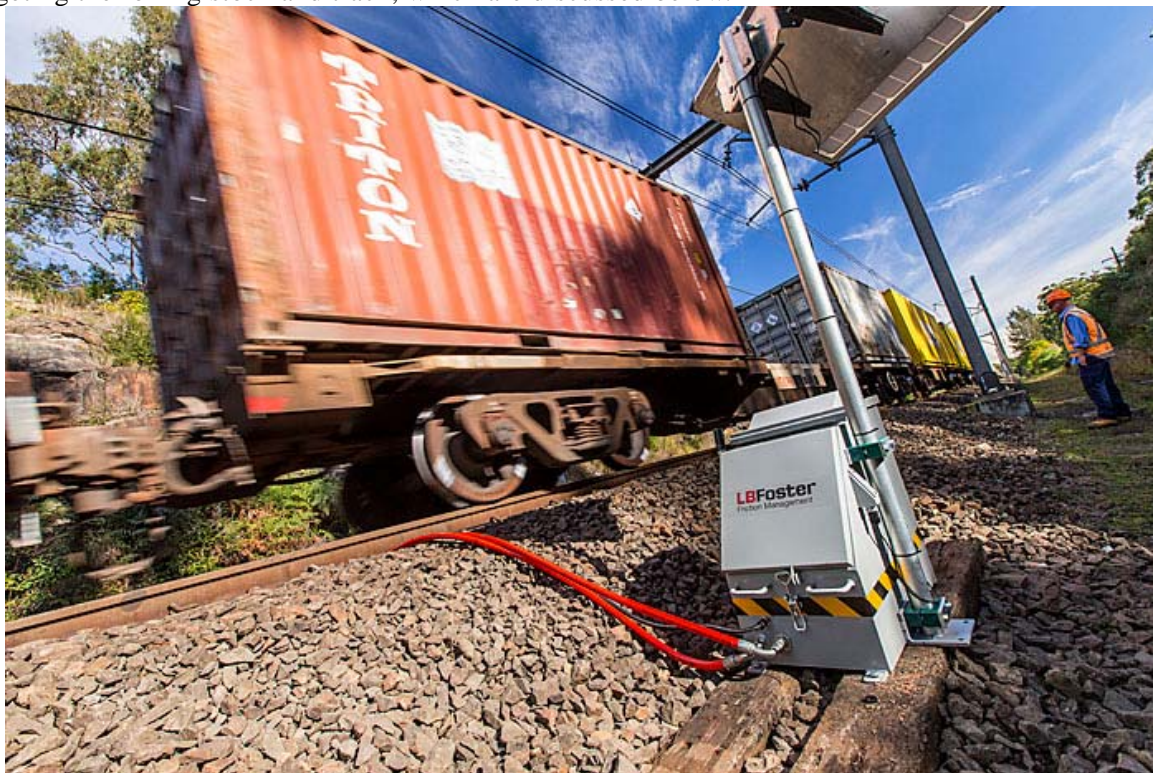
Figure 3 – TfNSW installed modern electronic lubricators at several curve noise sites

TfNSW has successfully implemented best practice rail lubrication at a number of sites which have experienced high levels of squeal. This involved a) installing modern, electronic lubricators, as shown

in Figure 3, in place of the unreliable and ineffective mechanical lubricators, and b) using modern, purpose designed rail greases. This combination provided effective grease coverage of the gauge corner of the rail throughout each track section. The lubricators have operated relatively maintenance free with near 100% reliability, significantly reducing maintenance costs. Another advantage of the modern electronic lubricators is that servicing can be conducted outside the danger zone, eliminating the risk of being struck by trains that is associated with servicing mechanical lubricators. The incidence of severe wheel squeal was reduced at the lubricated sites, but severe squeal was not eliminated. Effective lubrication is seen as a key component of effective squeal mitigation (as well as a necessary component of proper maintenance of the rail asset), which works in parallel with measures targeting the rolling stock and track, which are discussed below.

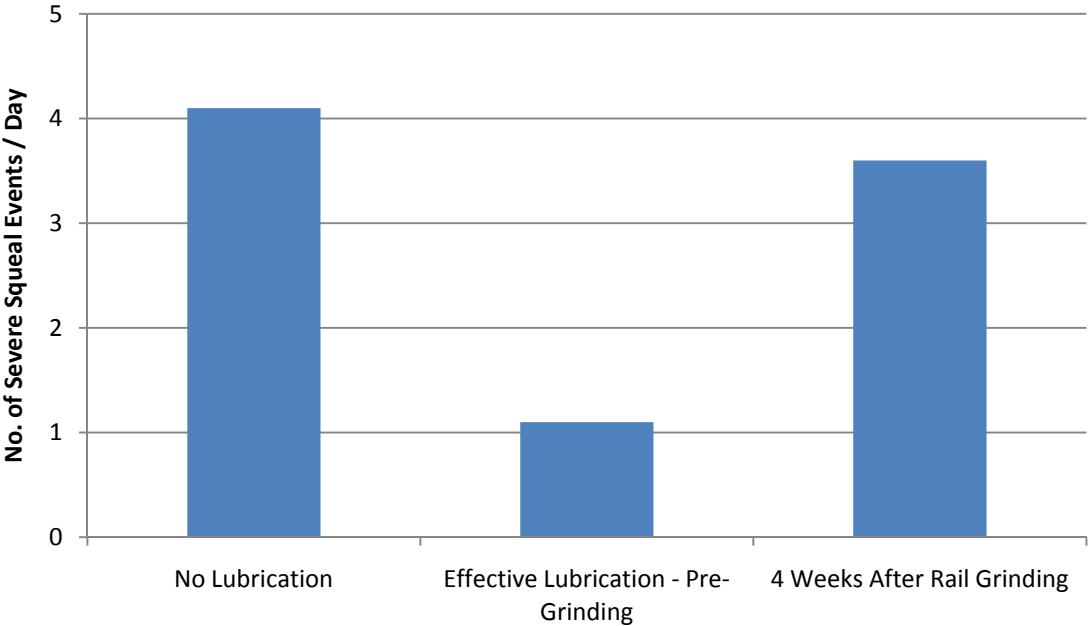
Figure 4 – Effect of poorly executed rail grinding on the incidence of squeal

Another important aspect of wheel/rail interaction is profile, i.e. the cross sectional shape of the wheels and rails. The rail profile is managed through rail grinding whereby purpose designed machines with large numbers of grinding stones remove metal from the rail so as to impart a carefully designed cross sectional shape. When the wheel and rail profiles are properly managed, the contact is spread and hence the contact stresses are reduced. Under these conditions, rail grease can effectively lubricate the gauge corner contact area and thereby reduce wear and noise. Unfortunately, poorly executed rail grinding can lead to severe two point contact between the wheel and rail in tight curves which can increase contact stresses and undermine the effectiveness of the grease. This can lead to increases in curve noise, as shown in Figure 4, which shows the incidence of squeal before and after grinding at a curve in Sydney. The incidence of squeal has reduced over time as the rail has worn to a more conformal shape, but has still not returned to the pre-grinding levels nearly twelve months after the rail was ground.

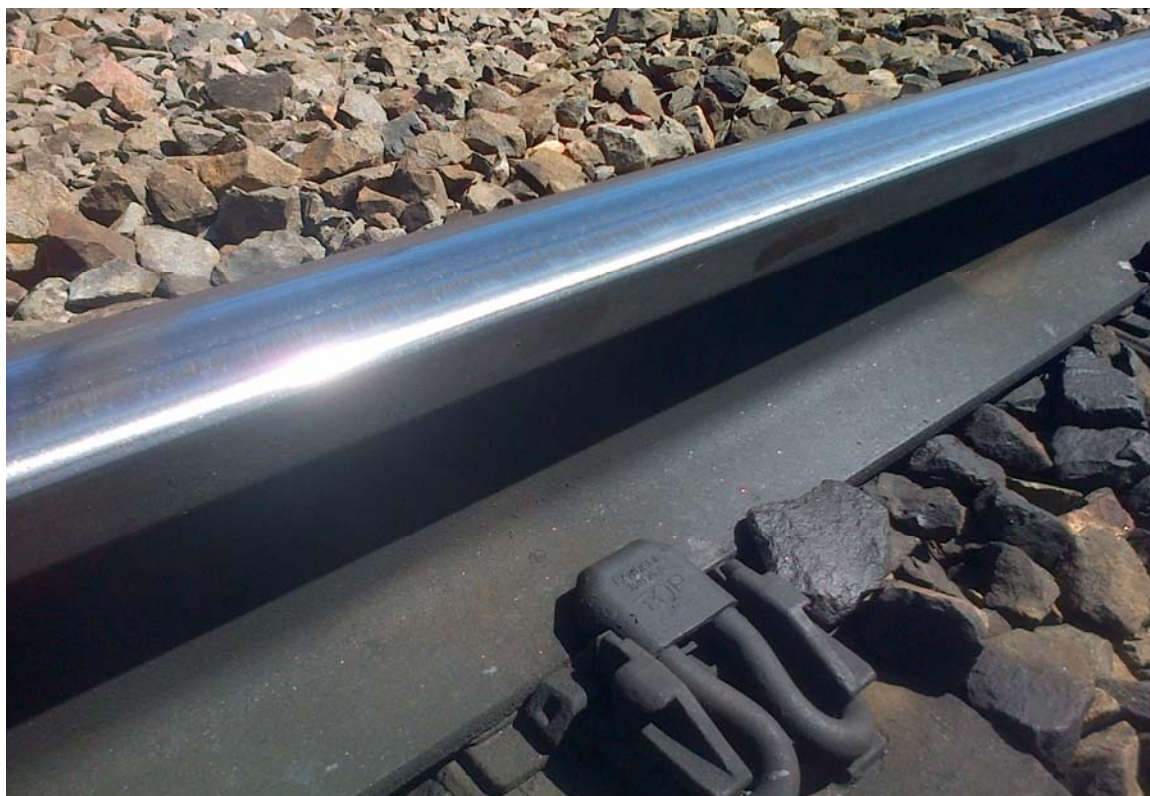
Figure 5 – The LOW rail on a tight curve showing a clear running band on the gauge corner. The gauge corner and face would be rusty in the absence of wheel contact.

Wayside measurement systems for recording AoA can be expensive. A quick indication of bogie steering can be obtained however from inspection of the rails in a tight curve. On a wagon with good steering performance, the leading wheelsets on both the leading and trailing bogies will attack the HIGH rail. We have shown that, by contrast, a consequence of poor rotation and bogie warp is that both wheelsets on the leading bogie will attack the HIGH rail and both wheelsets on the trailing bogie will attack the LOW rail. Hence, if there is clear evidence of wear on the gauge corner/face of the LOW rail, such as that shown in Figure 5, then it is likely that some wagons using the track are experiencing poor rotation.

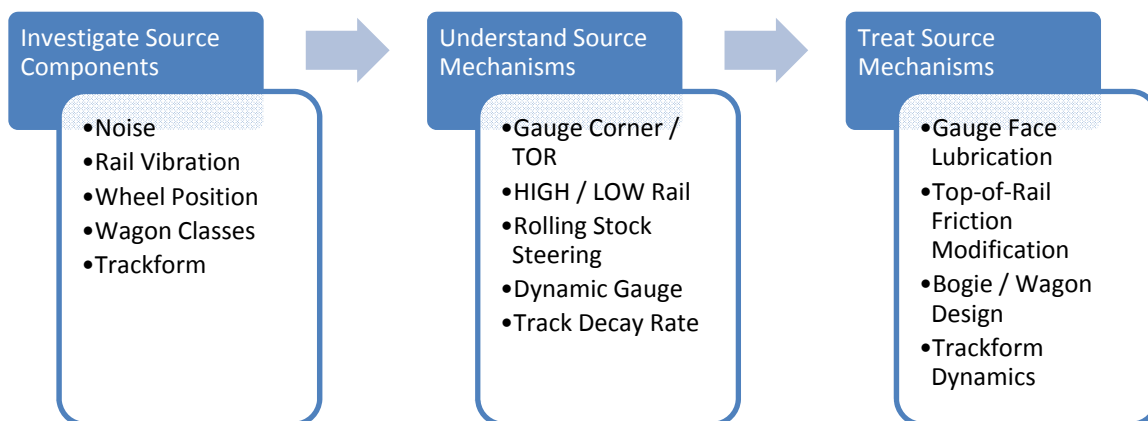
Figure 6 - Curve noise mitigation as a classic noise control problem

The various bodies of work described above can be understood in terms of a classic noise control approach, as summarized in Figure 6.

The first stage of this approach is to understand the noise source components, as described in Section 2, and to assess their impacts. This includes quantifying the squeal noise issue, separating wheel squeal from other noise sources, identifying which wheels are squealing and the contributions from the HIGH and LOW rail.

Based on this information, especially when a large data set is available to support statistical analyses and trending, an understanding of the source mechanisms may emerge. In our case, the data identified the rolling stock steering of particular wagon classes, and the HIGH rail gauge corner, as key components in the generation of squeal.

Finally, solutions can be targeted at the specific source mechanisms. This has included implementing effective lubrication and working with rail operators to improve rolling stock curving performance.
