Influence of design and leakages of the window-wall connection on the sound insulation.

Heinz FERK¹; Blasius BUCHEGGER²; Marlon MEISSNITZER³

^{1,2,3} Graz University of Technology, Austria

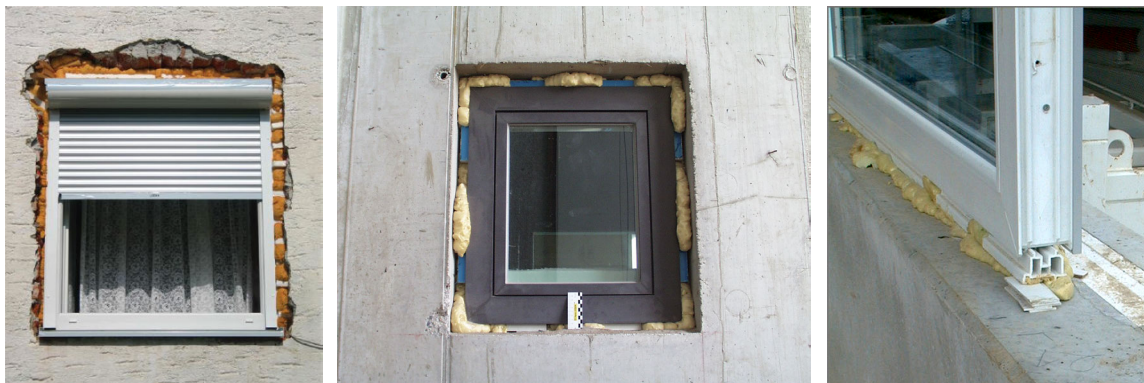
Figure 2 – Examples for bad window-wall connections

As is well known, the sound transmission index of small openings, holes or slits is wave-length dependent and can become higher than one. The reasons for this undesired property are diffraction effects of sound waves at the edges of the opening and also resonance effects of the opening itself.

A second important influence is the nearness of reflecting surfaces near the opening. Therefore it is important to pay attention to a tight design of the joint especially in edges and corners.

The above mentioned influences can lead to drastic reduction of the sound insulation performance of installed windows, caused by small defects in the connection to the wall. In the following chapter some examples of that influence are presented as measured under laboratory conditions and the effect on sound reduction index is shown.

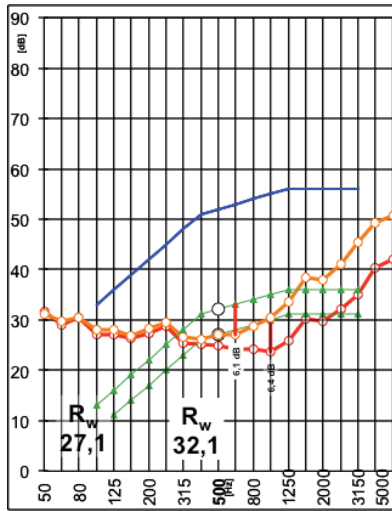
Wood/alu frame
glazing:
8 VSG – 20 – b6
glass –spacer - glass
 $R_w = 41$ dB
Slit:
width: 25 mm
mineral wool with
sealing tape source room
 $R_w = 32$ dB

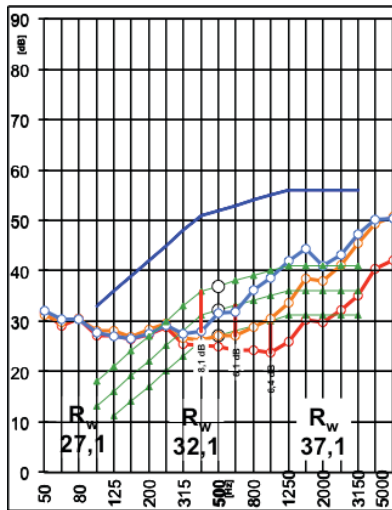
Wood/alu frame
glazing:
8 VSG – 20 – b6
glass –spacer - glass
 $R_w = 41$ dB
Slit:
width: 25 mm
mineral wool with
sealing tape both sides
 $R_w = 37$ dB

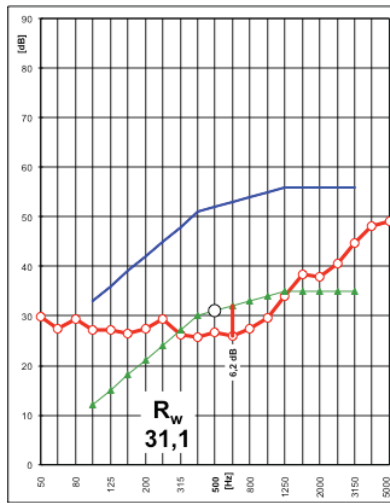
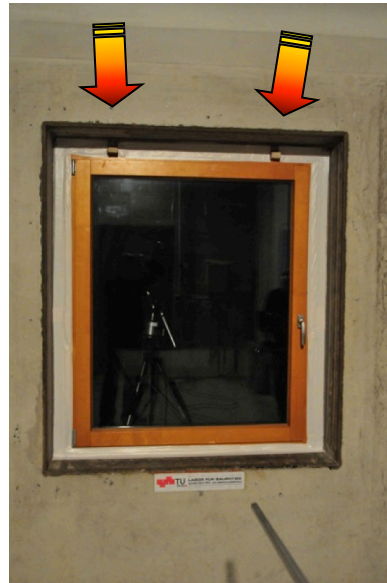
Wood/alu frame
glazing:
8 VSG – 20 – b6
glass –spacer - glass
 $R_w = 41$ dB
Slit:
width: 25 mm
mineral wool with
sealing tape source both
sides
+ 2 wedges: $R_w = 31$ dB
wedges removed:
 $R_w = 29$ dB

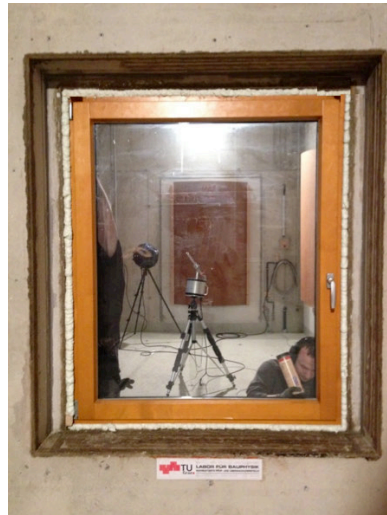
Wood/alu frame
glazing:
8 VSG – 20 – b6
glass –spacer - glass
 $R_w = 41$ dB
Slit: width: 25 mm
PU Foam uncut
 $R_w = 37 - 39$ dB
cutted + sealing tape
both sides:
 $R_w = 40$ dB

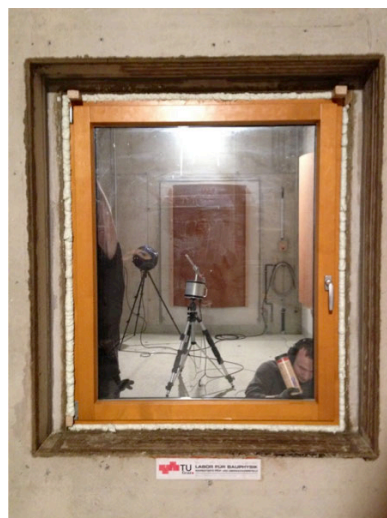
Wood/alu frame
glazing:
8 VSG – 20 – b6
glass –spacer - glass
 $R_w = 41$ dB
Slit:
width: 25 mm
PU Foam uncut, wedges
withdrawn
+ sealing tape both sides
 $R_w = 31$ dB

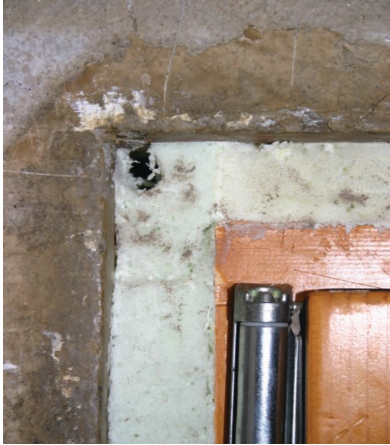
Wood/aluminium frame glazing: 8 VSG – 20 – b6 glass –spacer - glass $R_w = 41$ dB slit width: 25 mm PU Foam cut Open slit to parapet $R_w = 15$ dB circumferential open slit: $R_w = 9$ dB

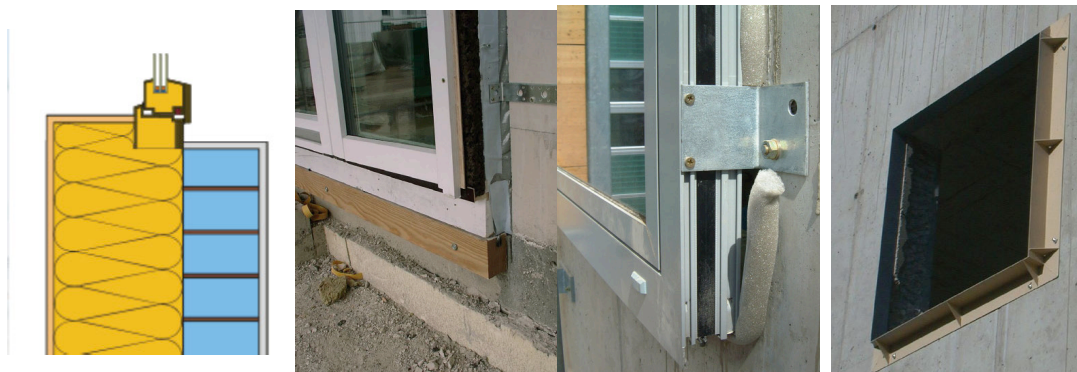
Figure 4 –window mounting in the insulation layer

Especially for window connections of low energy houses sound insulation aspects are neglected, as the following examples show. In this cases a circumferential steel framing should be preferred to get a satisfying airborne sound insulation, especially in areas with a higher exterior sound level.

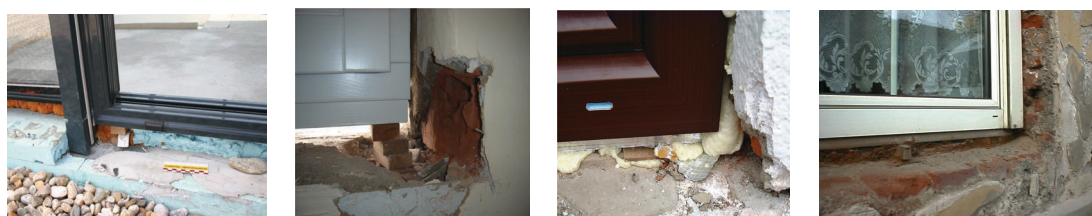
Figure 4 –building refurbishment: bad window mounting examples

A second big problem for a bad sound insulation performance are sometimes the window replacement to get a better thermal insulation performance. The proper refurbishment of the reveal seems to be a problem with regard to time constrains.
