The impact of the geometry of rail welds on noise level in urban environments

ABSTRACT

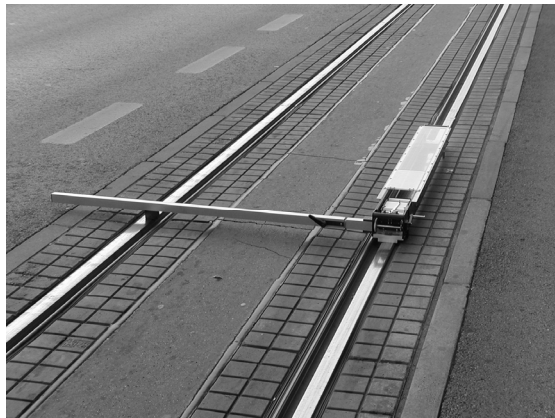
Figure 11. The profilograph – brand name "CEMAFER"

Prior to measuring noise levels, the geometry of the rail running surface at rail welds was measured. This measurement was conducted with a profilograph (device for measuring rail unevenness), Figure 11. This device has the capacity of measuring rail running surface irregularities at distances of 18, 23 and 33 mm from the running edge of the rail.

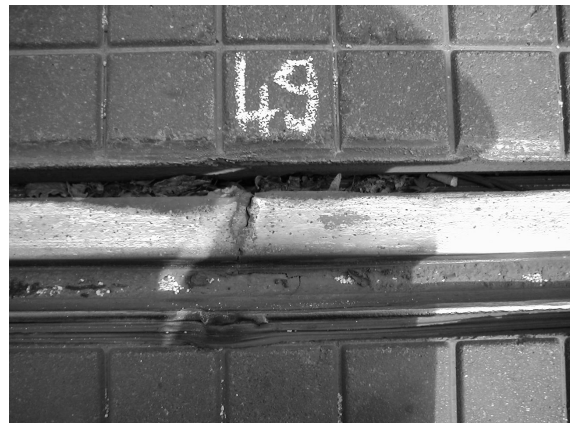
Figure 13a. Picture of weld - Location B

Photographs of a weld on the Zagreb tram track and the recorded running surface are seen in Figures 12a and 12b (Location A) and Figures 13a and 13b (Location B). Following measurement of the unevenness geometry, an initial measurement of noise was conducted in the case with unevenness at the running surface (Figure 14a) and following repairs to the unevenness (Figure 14b), noise level measurements were repeated.

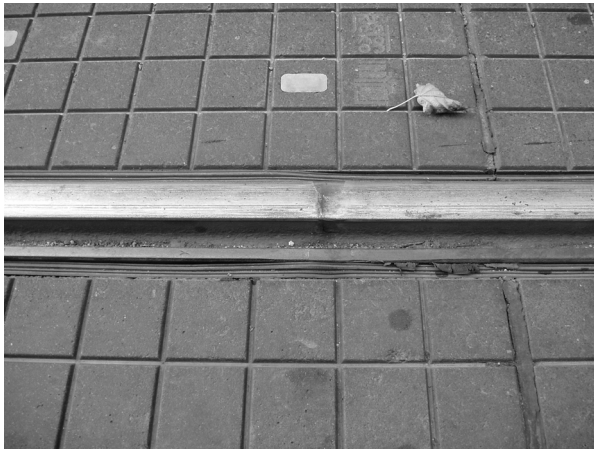
Figure 14a. Unrepaired rail weld – Location A

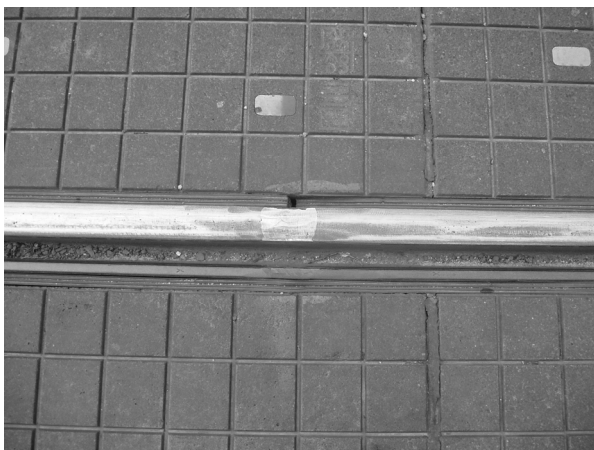
Figure 14b. Repaired rail weld - Location A

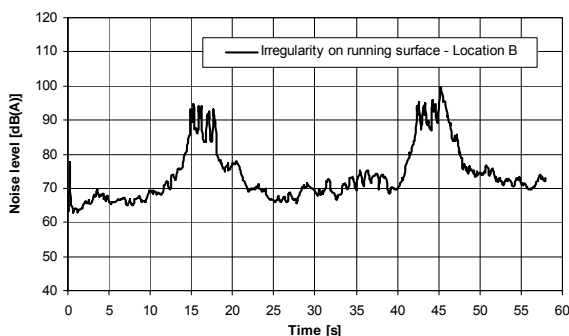
Figure 15. Characteristic depiction of changes in noise level over time

Noise levels were measured during tram passby, for a period of 20 to 40 seconds (depending on the tram driving speed). A characteristic depiction of the changes in noise levels over time are shown in Figure 15. The diagram shows the measurement noise levels at the time of passage of two tram vehicles over the irregularity in the rail weld. This diagram clearly shows the passage of each axle of the vehicle over the rail surface irregularity.

The maximum noise levels (peaks) appeared during the passage of tram vehicles, which is evident in Figures 15 and 16a.

the irregularity and results in a significant increase in noise levels. The increased noise levels (peaks shown in figures) are clearly seen in the characteristic depiction of noise levels over time in Figures 15 and 16. Following repairs to the irregularities, the sudden jumps in the noise level diagrams disappear and the maximum noise levels are thereby decreased (Figure 16b). In addition to comparing noise levels prior to and following repairs to weld irregularities, a comparison was also conducted of the mean values of noise level peaks dependent upon the type of tram. Tram vehicles which passed over the rails which were the subject of this study were investigated, as noted in point 2. The mean values of noise level peaks dependent upon tram type is shown in Figure 18 for the measurement site at Location A and in Figure 19 for the measurement site at Location B.

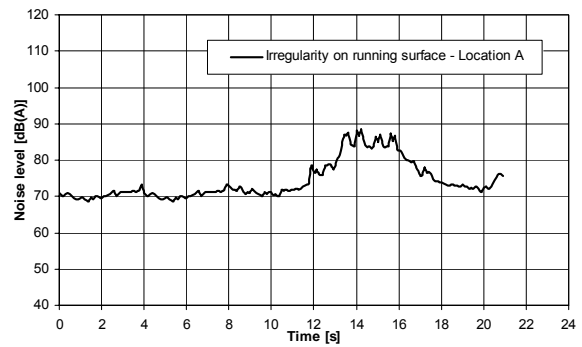
Figure 16a. Noise levels prior weld repairs

The results of measurements taken at Location A with the presence of irregularity in the rail surface and following repairs to the rail surface are shown on Figures 16a and 16b.

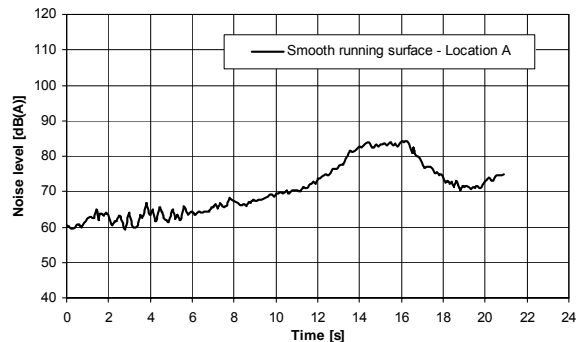
Figure 16b. Noise levels after weld repairs

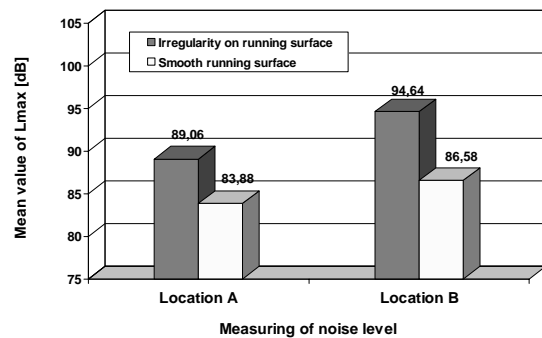
Figure 17. Noise levels prior to and following weld repairs

To assess the impact of rail weld geometry on noise levels, peak noise levels were used. The reason for this lies in the fact that equivalent levels depend on the overall noise levels in the measurement period, and also contain noise from other traffic participants. The results of the peak noise levels were statistically analysed and the mean values of peak noise levels during tram passage on the uneven rail surface and the smooth rail surface are shown in Figure 17.

As is seen in Figure 17, the mean peak noise levels following repairs are 6 to 8dB lower than measurements taken with the presence of rail surface irregularities (at the same location). Comparison of results of measurements prior to and following rail weld repairs at Locations A and B, it is clear that the level of noise at Location A is about 5dB less (prior to weld repairs) and about 3dB less (following weld repairs). The increased noise levels at Location B are due partially to a greater tram speed and partially to greater geometric irregularities. At Location A, dents in the weld were 1.2mm deep, while the same were 2.3mm deep at Location B. The greater depth of irregularities is caused by the strong impact of the vehicle wheel at the moment the vehicle passes over

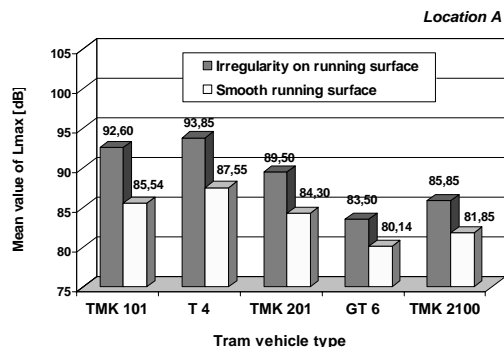
Figure 18. Mean value of maximum noise depending on the tram type – Location A

The comparison of mean values of peak noise levels shows that the passage of the Type GT6 and Type TMK 2100 cause the least noise increase at Location A. There are no trams of these types at Location B, so a comparison of results on various irregular driving surfaces was not possible. At both locations, the Type T4 showed the poorest results considering noise levels which arose at the time of passage, on both rail running surfaces with irregularities and those without irregularities. The noise levels for this type of tram was 3 to 10dB higher than the remaining tram vehicle types, particularly where the rail running surface was uneven.
