Control of sound insulation in glass facades at Oslo's Opera House

Sigmund Olafsen, Per Kåre Limmestad

Brekke & Strand akustikk as, Oslo, Norway

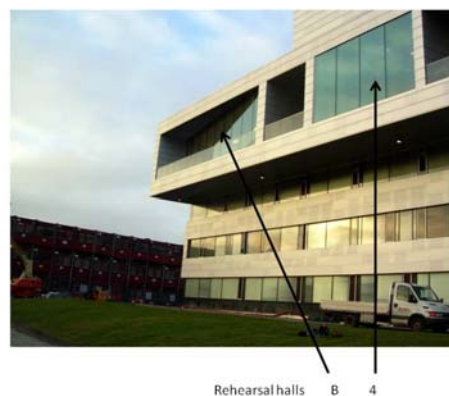
Figure 1, Rehearsal halls B and 4

There are three rehearsal halls on the east façade of Oslo's new opera house. All these halls have an external wall with a glass-only facade. The outside of these glass walls are exposed to steady traffic noise of around 70 dB daytime L_{Aeq} . Strict requirements had been given for the sound insulation of these facades and the indoor levels. The final requirements were as given in the table below.

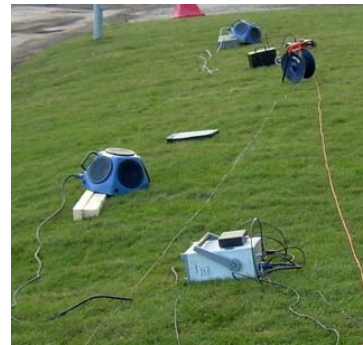
Figure 3, loudspeakers and amplifiers in place

- Two loudspeakers were used simultaneously to give a more uniform and diffuse sound field.
- The facades are at an oblique angle, so the microphone was at somewhat varying distances in front of the facades.

For each of the halls, 5-6 microphone positions were used on the outside of the façade. Both the loudspeakers were Norsonic 250’s. One Norsonic 260 and one Norsonic 280 amplifier were used. For the sound level and reverberation time measurements a Norsonic 118 was used.

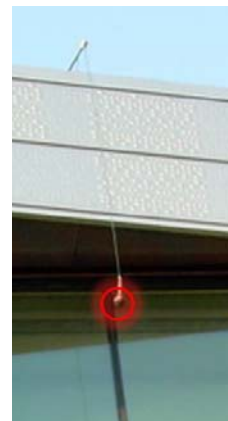
Figure 4, outdoor microphone position

The main purpose of the measurements was to achieve a good estimate of the indoor level. The chosen method of façade sound insulation measurement is based on mounting the microphone 1-2 m in front of the façade. There’s a known theoretical problem with the method in that there may be a comb filter effect. This is due to destructive interference between direct sound from the loudspeaker and reflected sound from the façade to be tested. The ISO 140-5 [2] mentions a problem with measurements of façade insulation with microphones in front of the façade instead of fastened directly onto the façade. However, the standard only says that this might cause unknown systematic errors at low frequencies.

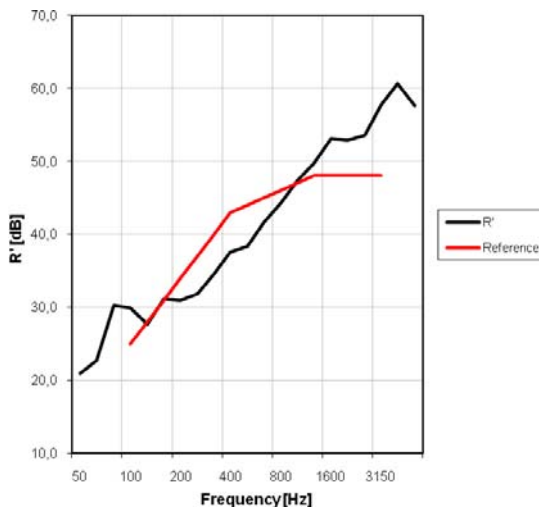
Figure 5, rehearsal hall A

The R' curves from the three measurements are shown below together with the reference curve. For all the three measurements the frequency range 200 – 800 Hz is critical for the achieved sound insulation. Figure 5 shows rehearsal hall A, figure 6 shows rehearsal hall B and figure 7 shows rehearsal hall 4.

It has been shown [5] that the quality of details can effect the achieved sound insulation of glass facades to a large extent. The measurements from rehearsal halls A and B show no clear dips that indicate leakages, the measurement from rehearsal hall 4 has a dip at 2000 – 2500 Hz which could be due to a small leakage.

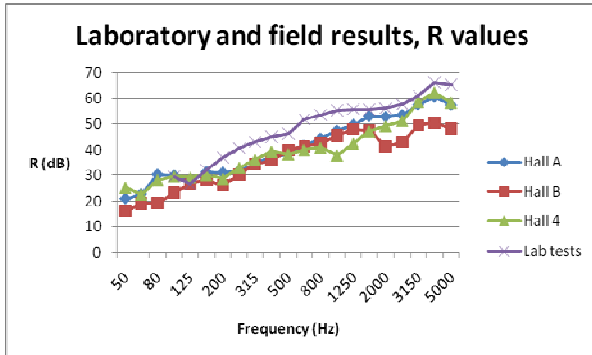
Figure 8, laboratory and field results

The glass formula used in the facades were expected from laboratory measurements and theoretical analysis to give a value of R'_{w+Ctr} of 41 dB [4]. The results were R'_{w+Ctr} of 33-37 dB as shown in table 2. Figure 8 below shows our field results compared to the laboratory results.

Laboratory results from Glaverbel have been quoted.

Three different possible explanations of this have been considered:

- Systematic error due to the measurement procedure
- Quality of design and craftsmanship of details
- Double wall resonances between the glasses

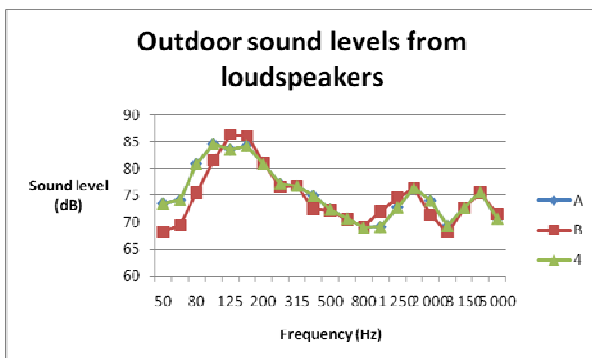
Figure 9, outdoor levels

In figure 9 below the measured values outside the facades are shown.

The spectra look quite what could be expected from the specifications of the loudspeaker and possible ground effects, but there is no indication of a comb filter with repeating dips in the spectrum of the outdoor level. The dip at 2500 Hz has no effect on the resulting sound insulation index, at that frequency range the measured insulation is clearly above the reference curve anyway.
