**ICSV14**  
Cairns • Australia  
9-12 July, 2007

## **ABNORMAL RESONANCE NOISE OF EXHAUST GAS PASSAGE IN URBAN COMBINED POWER PLANT**

### **Abstract**

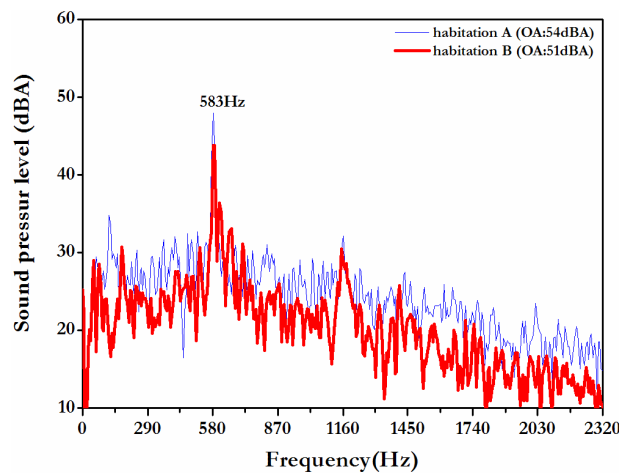
In the surrounding area, 585Hz noise was within 38dBA but it was >48dBA (refer to Figure 1) under abnormal amplification, which indicates that noise was amplified by >10dBA at least in the surrounding area within 1km.

Figure 1. Abnormal noise spectrum in the surrounding area of the power plant

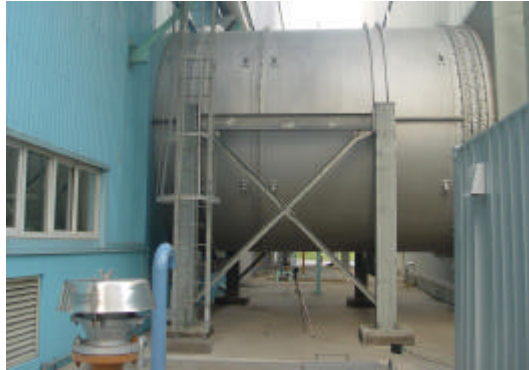
As a result of investigating the primary transformer, the compressor, the air inlet, the seawater circulating pump and exhaust duct in the plant on the basis of the spectrums of abnormally amplified noises analysed in the surrounding area, 585Hz noise at the exhaust duct was amplified at >80% operation load. Figure 2 shows the exhaust duct of a gas turbine where abnormal sound was found. The abnormal noise that the total noise level was >85dBA was emitted at 585Hz noise that was 80dBA in the noise spectrum.

Figure 2. Noise measurement at the exhaust duct of a gas turbine

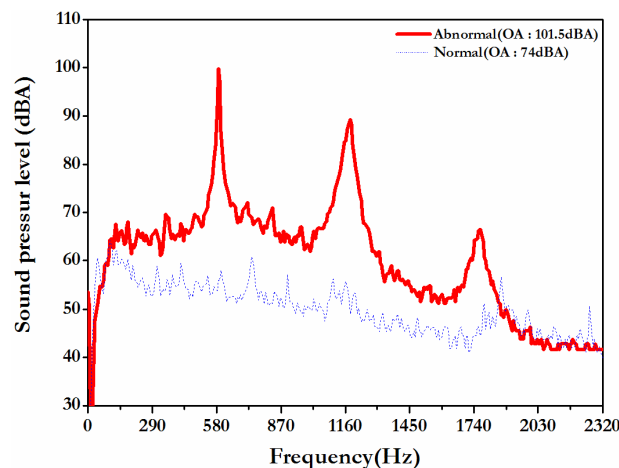
Figure 3 shows noise spectrum at the outlet of the smokestack in the power plant. Figure 3 shows that the same amplified noise at 585Hz is discharged through the outlet of the smokestack. That is, it is estimated that the intermittently amplified noise at 585Hz which was found in the habitation site would occur at the exhaust path of a gas turbine, pass through the Heat Recovery Steam Generator (HRSG), and be discharged through the smokestack.

Compared to no abnormal amplification, noise at the outlet of the smokestack was increased by 20dBA or more when abnormally amplified noise was transmitted at >80% operating load, and the total noise level was increased from 74dBA to 101.5dBA.

Figure 3. Abnormally amplified spectrum of 585Hz harmonic noises generated from the outlet of the smokestack

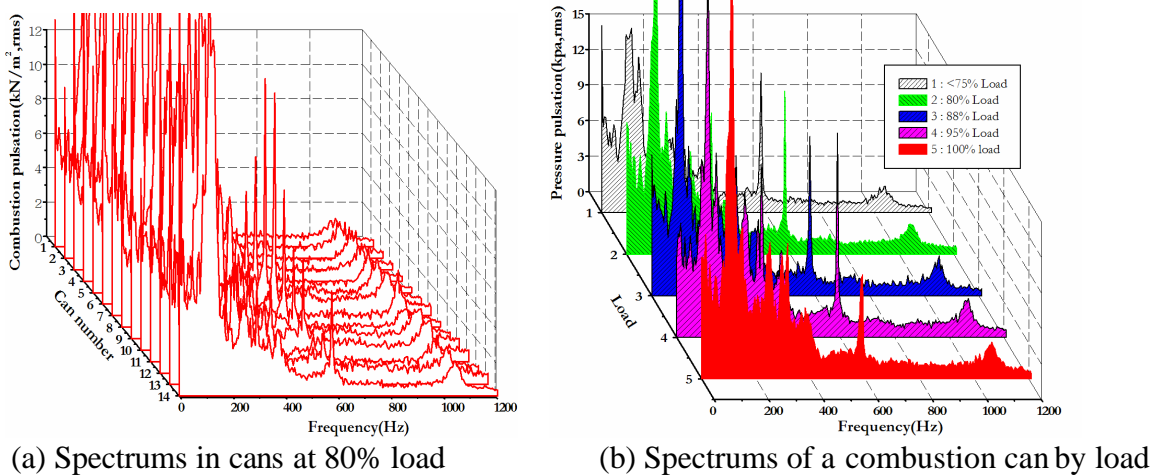
A gas turbine is designed to rotate by exhaust at high temperature and high pressure incoming from the combustion part. The pulsation of burning vibration generated from the combustion cans may influence the strut, the diffuser and the exhaust duct through the gas turbine, where a possibility may be examined that it may lead to excitation of 585Hz's standing wave of the strut, the diffuser or the exhaust duct. The combustion part of gas turbine is composed of 14 cans, and the dynamic pressure measurement port is installed per can. Figure 4(a) shows the explosive pulsating pressure spectrums of 14 combustion cans as tested at 80% load. The pressure pulsation of 585Hz was found in all the 14 combustion cans which might occur when abnormal

noise is amplified at an exhaust duct, and the characteristic of the pressure pulsation nearly equivalent to 585Hz was analysed even under operating load without abnormal amplification at the duct as shown in Figure 4(b); therefore it can be deemed that the abnormally amplified noise at 585Hz shown at the exhaust path of a gas turbine was caused by the pulsating pressure at 585Hz generated from the combustion cans.

Figure 4. Dynamic pressures at the combustion cans of gas turbine

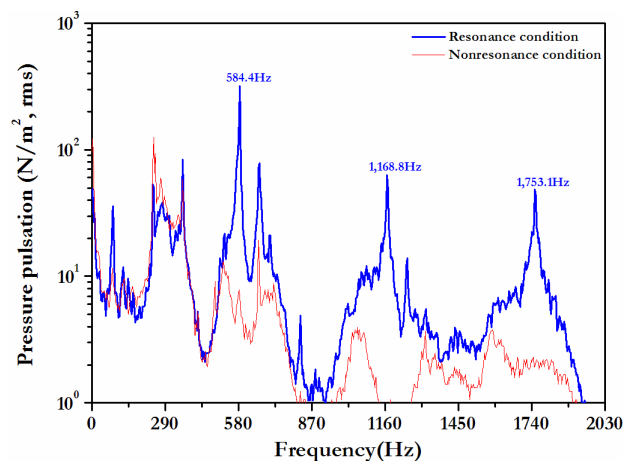
Figure 5 shows exhaust pulsating pressure spectrums of the duct as tested under amplification at the exhaust passageway of a gas turbine.

Figure 5. Dynamic pressure spectrum measured at the the exhaust duct of a gas turbine

For exhaust gas pulsating pressure under abnormal amplification, the 585Hz frequency shown in the combustion cans was displayed at the passageway after the gas turbine, and the HRSG displayed passage of the 585Hz frequency. In conclusion, it is estimated that amplification pressure at 585Hz is caused by the situation that sound impedance at the exhaust passageway for 585Hz frequency is lower than other frequencies to be readily passed.

Figure 8 shows resonance mode in the radius direction at 586.3Hz as analysed at the strut section from the gas turbine, which is represented into 577Hz and a pair. When the result of Figure 5 and Figure 6 is compared to that of Figure 8, it is derived that at the strut section of double cylinder structure, as the strength of vibration source is fully increased, resonance of standing wave in the radius direction occurs if the inner cylinder wall has horizontal structure even if the outer cylinder wall is sloping. Figure 9 shows resonance mode at 584.6Hz as analysed in the circumference direction at the diffuser section from the strut, which is represented into 574.6Hz and a pair. 585Hz at the diffuser from the strut showed 3rd mode standing wave form in the circumference close to the inner cylinder wall as shown in Figure 7(b); therefore, the position that pulsating pressure at 585Hz arising out of the combustion can pulsating wave at 585Hz at the exhaust path is, primarily, the strut at the gas turbine outlet, and pulsating sound pressure at 585Hz amplified at the strut section is maintained and transmitted in the form of amplifying standing wave of the 3rd mode at 585Hz in the circumference of the diffuser section from the strut, and then it is discharged through the smokestack.

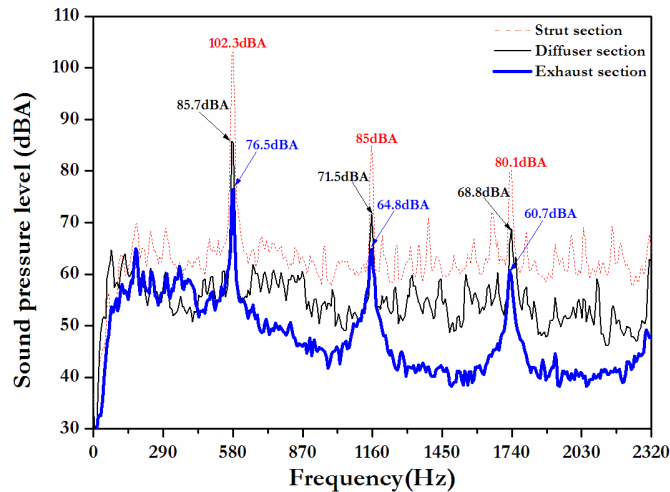
Figure 6 shows comparison of noise spectrums under abnormal amplification as tested at each

section of the strut, the diffuser and the exhaust duct. The amplified noise at 585Hz measured at the exhaust passageway was shown to be highest at the strut section as 102.3dBA. It was measured as 85dBA at the diffuser section and 76.5dBA at the exhaust duct, thus the resonance source of standing wave in the exhaust path was estimated as the strut section neighbouring on the last blade stage of a gas turbine.

Figure 6. Noise spectrum at each section of the exhaust passageway upon abnormal noise
