**ICSV14**  
Cairns • Australia  
9-12 July, 2007

## **INFLUENCE OF STIFFNESS AND MASS CHANGES ON EIGEN FREQUENCIES OF BEAM WITH PIEZO ELECTRIC PATCH**

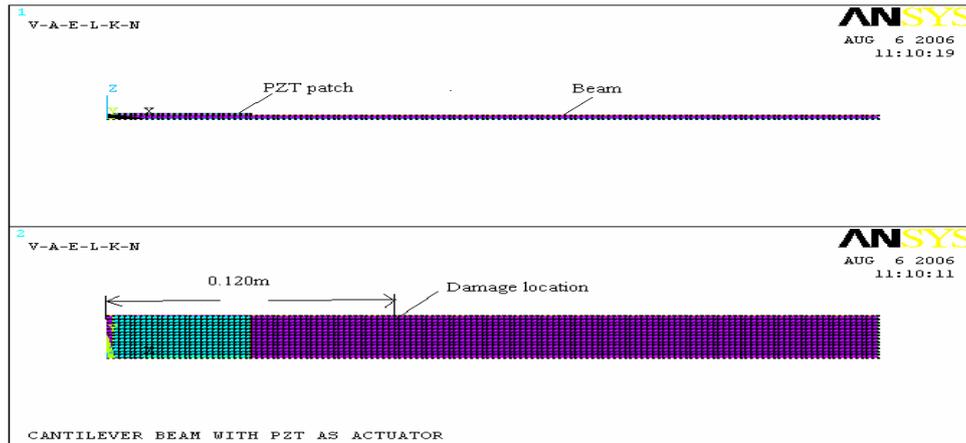
Figure 1. ANSYS model of the smart beam with thin PZT attached

In the modeling and analysis of piezoelectric crystals the typical finite elements used are the solid elements, where as in the analysis of this plate, usually shell elements are utilized. The smart beam a 0.280 x 0.025 x 0.002m aluminium beam modeled in cantilevered configuration with single 0.050 x 0.025 x 0.0009m PZT actuator placed on one surface of the beam closed to the clamped end as shown in Figure 1. The PZT is modeled by compatible solid elements SOLID5 (3-D Coupled-Field Solid) and beam with SOLID45 (3-D Structural Solid).

The element SOLID5 has eight nodes with up to six degrees of freedom at each node also has large deflection and stress stiffening capabilities. The element SOLID45 is defined by eight nodes having three degrees of freedom at each node: translations in the nodal x, y, and z directions also the element has plasticity, creep, swelling, stress stiffening, large deflection, and large strain capabilities. The Length of beam is divided into 140 elements and width is 25 elements. So the simulated model has total of 3500 elements. Damage is simulated at a distance of 0.120m from fixed end by removing elements along the width of beam (i.e. for each damage case 5 elements are removed) The material properties of the beam and actuator (PZT) are listed in Table 1 and Table 2. Figure 1 shows the finite element model of the smart beam used for study. Modal analysis is carried out for different damage scenarios and compared the natural frequencies with experiment.

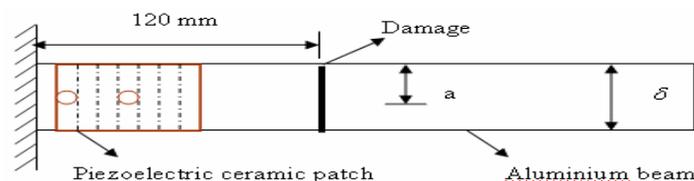
Figure2. Beam with bonded piezoelectric ceramic patch.

The beam width and thickness were 0.025 m and 0.002 m, respectively, while its length is 0.280 m and its material properties are shown in Table1. The piezoelectric actuators utilized were PZT 5A with dimensions of 0.0506 m length, 0.025 m width and 0.0009 m thickness as shown in Figure 2. The experimental set-up consists of a cantilever aluminium beam with one PZT actuator bonded to the structure as shown in Figure 3. The actuator was bonded on the upper surface at 0.005 m from the fixed end of the beam while the sensor here used is B&K Accelerometer is on the free end. These two locations were chosen such that all of the structure's mode shapes were excited by the actuator and sensed by the sensor.

As depicted in Figure 2, the damage is located at a distance of 0.120 m from the fixed end produced by cutting the beam with help of hexa blade with different depth along the width of beam. A crack depth ratio of 0 is considered no damage and a ratio  $a/\delta$  of 0.8 is considered as failure of the member. The PZT actuator receives an amplified sweep white noise signal with 10 V at frequency range 5 Hz to 1000 Hz from the function generator and provokes

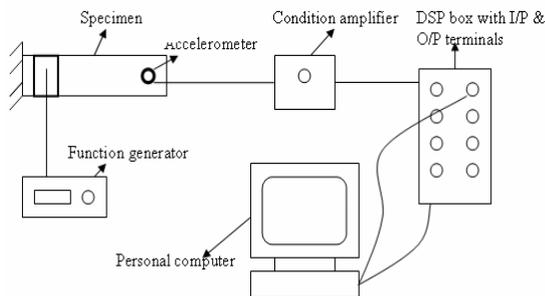
Figure 3. Schematic of the experimental set-up.

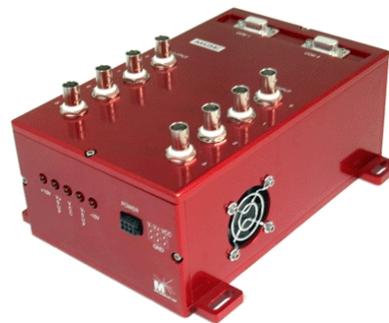
Figure 4. DSP box

This is important because different damages can affect different frequency ranges of a structure, and the resonant and anti resonant characteristics of a structure are very good indicator of damage. Other end of beam accelerometer senses the induced vibration in the beam and that signal amplified through condition amplifier and fed into the DSP box. The DSP box as shown in Figure 4 communicates with the PC running MATLAB through an RS232 serial port. It can perform data acquisition and generate signals like sine, random and arbitrary data from a '.mat' file. It can also perform sine dwell or random noise excitation (band limited) to identify the FRF characteristics of the plant, While data collection and interpretation is performed with a computer.

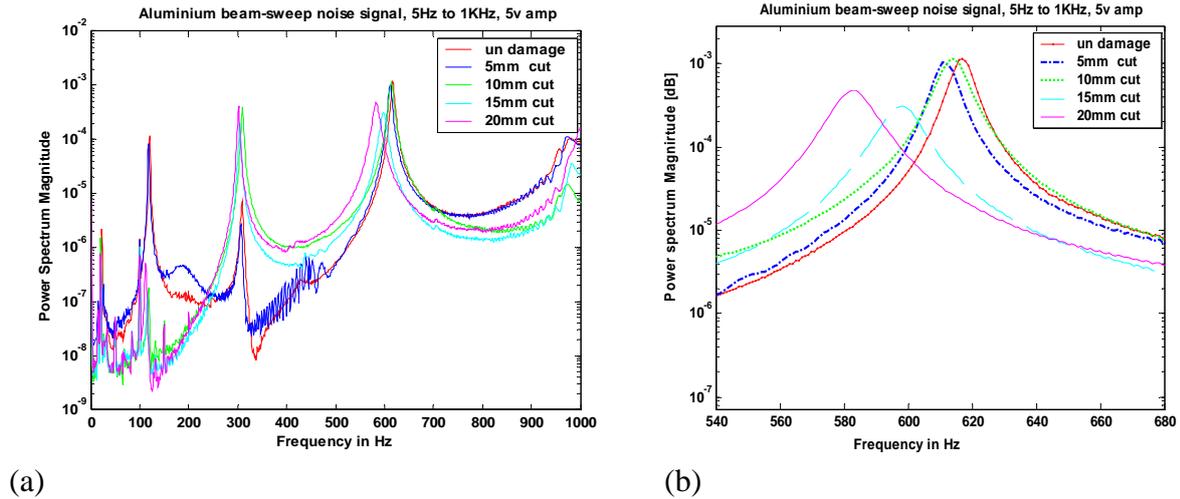
Figure 5. Power spectral magnitude plots. (a) Shift in frequency for all damage cases at 5 V amplitude of signal (b) Zoomed view in frequency range 540 Hz to 680 Hz.

When the specimen is subjected to frequency white noise ranging from 5 Hz to 1 KHz with an amplitude level 5 V. The influence of different damage cases can be seen on the power spectrum magnitude plot as shown in Figure 5a. Where one can notice that as damage size increase shift in the characteristic frequency peaks before and after the damage conditions also increases. Figure 5b the zoomed view in frequency range between 540 Hz to 680 Hz which is the sensitive mode for damage detection. The shift becomes even more significant as the white noise amplitude level is increased from 5 V to 10 V as shown in Figure 6a. The spectral magnitude shows an increase with increased signal level. Figure 6b the zoomed view in frequency range between 540 Hz to 680 Hz which is the sensitive mode for damage detection. Significant increase in amplitude of the power spectrum peaks for undamaged case by variation of excitation voltage from 5 V to 10 V a shown in Figure 7. If excite the system even at different amplitude there is no effect on frequency of system.

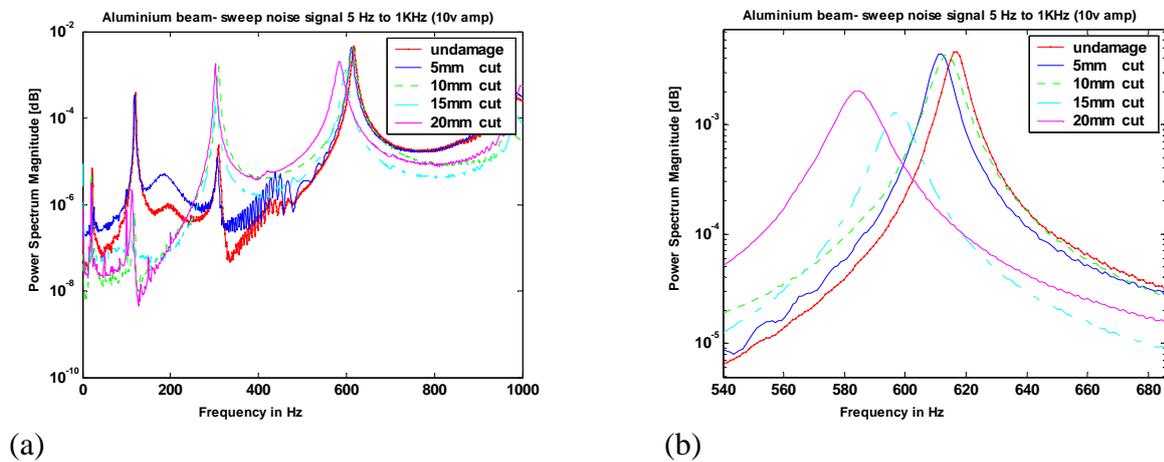
Figure 6. Power spectral magnitude plots. (a) Shift in frequency for all damage cases at 10 V amplitude of signal (b) Zoomed view in frequency range 540 Hz to 680 Hz.

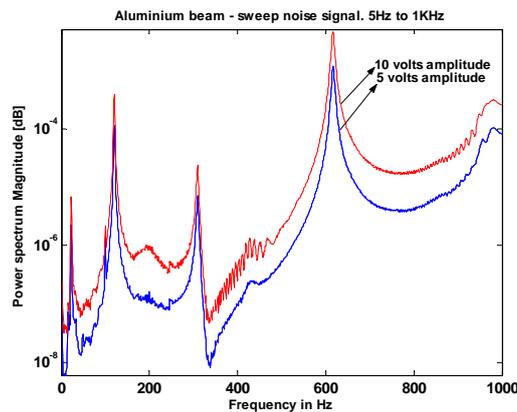
Figure 7. Power spectral magnitude plot for undamaged case with shift in frequency at 5 V and 10 V amplitude of signal

The variation of power spectrum magnitude response of beam due to attached masses at distinct locations. It shown that with increases in the amplitude of excitation signal from 5 V to 10 V there is no effect on the system frequencies but amplitude of spectrum getting changes.

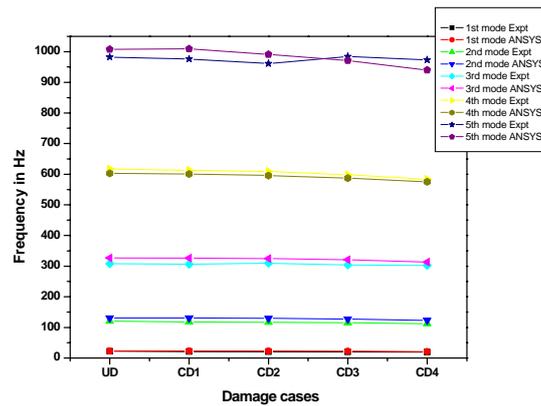
Figure 8: Comparison of initial five modal frequencies from ANSYS and experiment for different damage scenarios.

Modal data from both test cases (ANSYS and experiment) compared in terms of initial five frequencies for different damage scenarios as shown in Figure 8. Initial four modes are almost coincide in both the cases but in higher mode i.e. fifth mode the variation of frequencies is more.

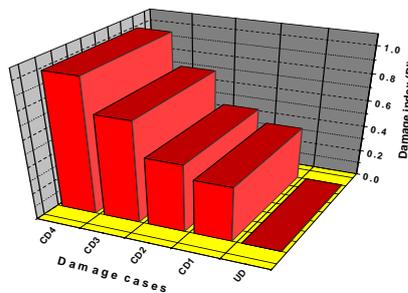
Figure 9. Quantification of different damage scenarios

The damage quantification bar graph is plotted in Figure 9. It could be observed that when crack depth ratio  $a/\delta$  exceeds 0.2 i.e. (CD1), the damage sharply increase and replacement of the cracked member would be necessary to avoid its failure.

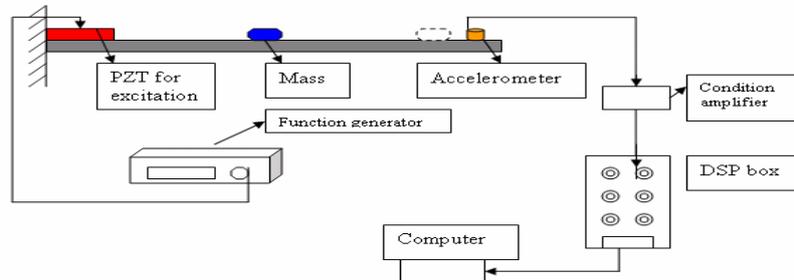
Figure 10. Schematic of the experimental set-up with position of mass at different locations.

Similar experimental has been repeated for the same cantilever beam by positioning the mass on top of the beam at its mid and free end of the span as shown in Figure 10. The standard weights in grams (10 and 20 gms) are used by applying on the beam with a very thin layer of wax.

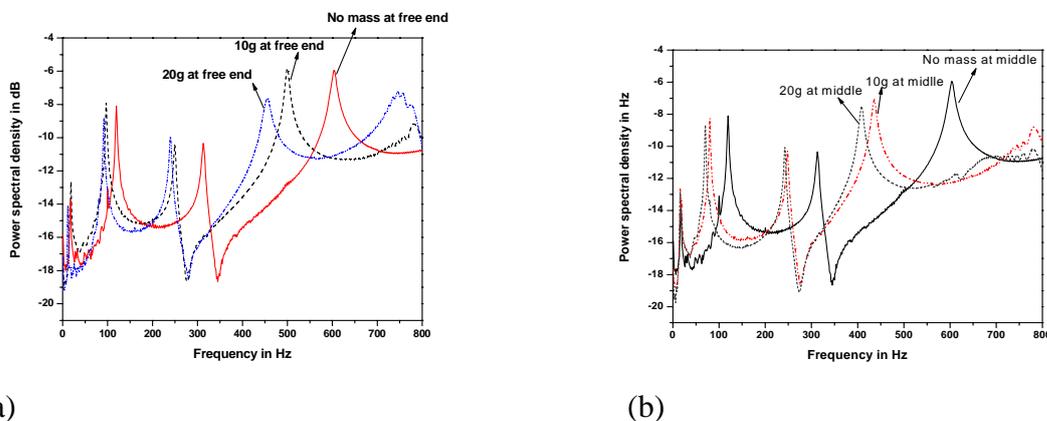
Figure 11. (a) Comparison of power spectrum magnitude with and with out additional mass at free end of the beam. (b) Comparison of power spectrum magnitude with and with out additional mass at mid span of beam.

It can be seen from the experimental results that power spectrum magnitude of the beam varies when the different masses attached at different locations. Since power spectrum magnitude is a characteristic of the structures which is independent of the applied force, observing the outstanding variations near the natural frequencies can clearly indicate the changes of structural properties due to the addition of 10g and 20g masses as shown in Figure 11a and 11b. The structure integrity is changed due to crack and masses the power spectrum magnitude will alter due to the stiffness changes of the structure.
