**FIFTH INTERNATIONAL CONGRESS ON SOUND AND VIBRATION**

**Diagnosis for Radial Rolling Contact Bearing  
using Acoustic Emission Technique  
(1st Report) : Acoustic Emission Source Location Method**

T. Yoshioka<sup>a</sup> and H. Mano<sup>b</sup>

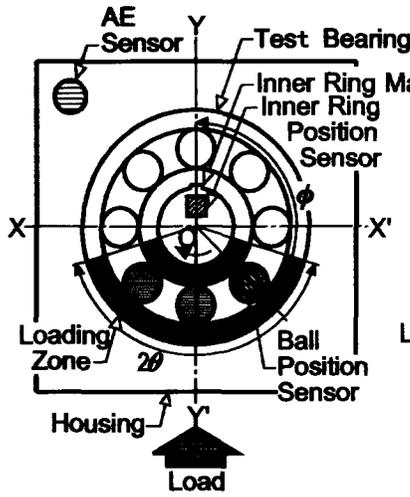
Figure 1 shows the arrangement of a test bearing and the sensors of the new location method. The test bearing is a deep groove ball bearing. Eight balls are assembled in it. The AE sensor is fixed on the housing of the test bearing. The inner ring position sensor is attached on the O-Y axis and generates a signal to measure the inner ring position when the marker on the inner race passes through in front of it. The ball position sensor is on the pitch circle of the test bearing clockwise at the angle of  $\phi$  around O from the O-Y axis and detects passage of a ball. A loading zone is induced in the test bearing between the angle of  $\pm \theta$  around the maximum rolling element load position (O-Y' axis) when the pure radial load is applied to it.

**Figure 1 Arrangement of Test Bearing and Sensors**

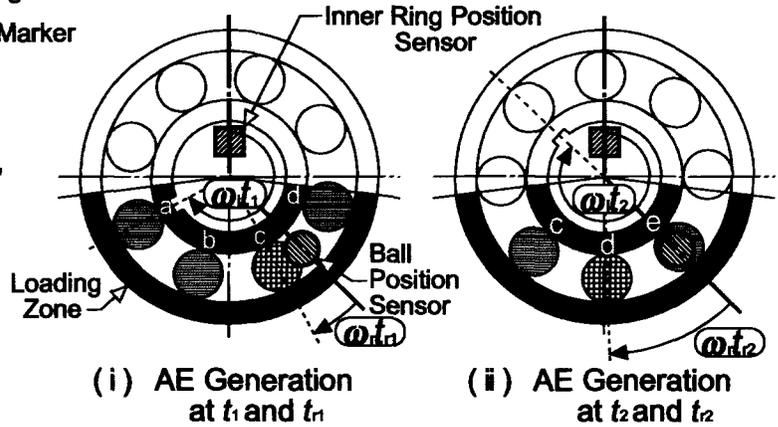
possible AE source positions. It is assumed that AE occurs at each time when the inner ring comes into contact with the balls as shown in Figure 2 (i) and (ii).  $\omega_i$  is a rotational angular velocity of the inner ring and  $\omega_r$  is a revolutionary angular velocity of the ball set.  $t_1$  and  $t_2$  are the times from passage of the marker on the inner ring in front of the inner ring position sensor to each AE generation, respectively. And  $t_{r1}$  and  $t_{r2}$  are the times from passage of a ball in front of the ball position sensor to each AE generation, respectively. The possible AE source positions are the points a, b, c and d at the AE generation of Fig. 2 (i), and the points c, d and e at the generation of Fig. 2 (ii).

**Figure 2 Contact Conditions of Inner Ring and Balls at AE generation**

The AE location method for an inner race decides the points on the inner raceway which come into contact with balls within the loading zone at the moment of AE generation as

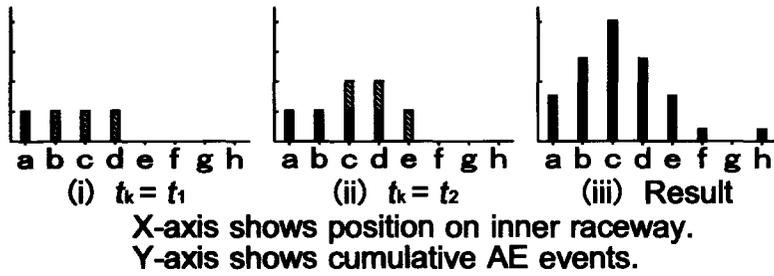
The process of the AE location is illustrated in Fig. 3 as a histogram. The X-axis of Fig. 3 indicates positions on the inner raceway and the Y-axis the cumulative number of AE events. At the first AE generation of  $t_k = t_1$ , one event is added to the position a, b, c and d as shown in Fig. 3 (i), respectively. In the second generation of  $t_k = t_2$ , one event is added to the position c, d and e as shown in Fig. 3 (ii). After many repetitions, we could obtain a histogram like as shown in Fig. 3 (iii). The histogram has the highest peak and plural peaks symmetrically in it. From the location result, the position of the actual AE source on the inner raceway is presumed to be the position of the highest peak of the histogram.

Figure 3 Location Process of Inner Ring

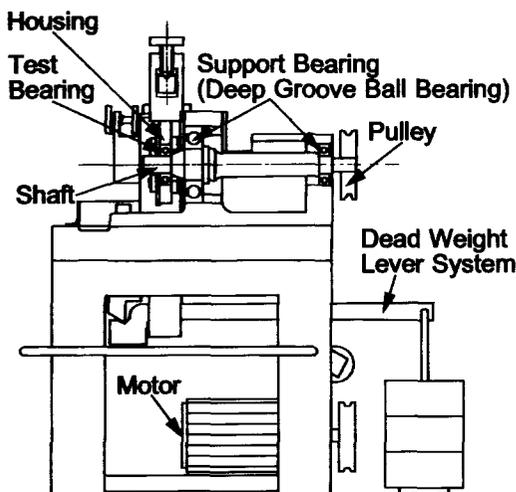
The bearing testing machine used in the rolling contact fatigue tests is illustrated in Figure 4. A main shaft was supported by two deep groove ball bearings and the test bearing was attached to the end of the shaft. A pulley driven with a motor through v-belt was fixed at the other end. The load was statically applied to the test bearing by means of a dead weight lever system as a pure radial load.

Figure 4 Bearing Testing Machine

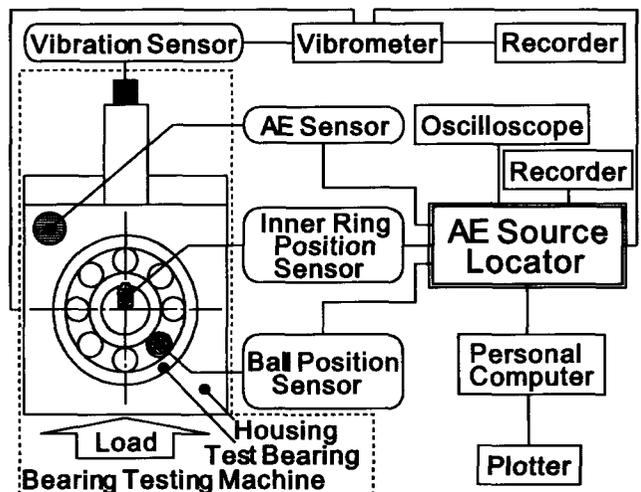
The block diagram in Figure 5 shows an AE and vibration measurement system, including a developed AE source locator. An AE sensor, position sensors which detect rotation of the inner ring and revolution of the ball set and a vibration sensor were fixed on the bearing testing machine. The inner ring position sensor was fixed on O-Y axis and the ball position sensor was fixed at the angle of  $\phi = 135$  degrees around O from O-Y axis on the pitch circle of the test bearing as shown in Fig. 1. The signals detected by the AE sensor, the inner ring position sensor and the ball position sensor were sent to the locator. The locator decided the possible AE source positions according to these signals at every AE generation during the fatigue test, and the location results cumulated for each 5 min were memorized in the personal computer temporarily. The vibration acceleration detected by the vibration sensor was processed to a r.m.s. value in the vibrometer. When the r.m.s. value of vibration exceeded a preset level which depended on a spalling appearance in the fatigue test, a relay circuit of the vibrometer stopped the bearing testing machine automatically. Moreover, the locator which received the output of the relay circuit made the personal computer save the location results for 2 h 30 min just before the spalling appearance.

Figure 5 AE and Vibration Measuring System and AE Source Locator

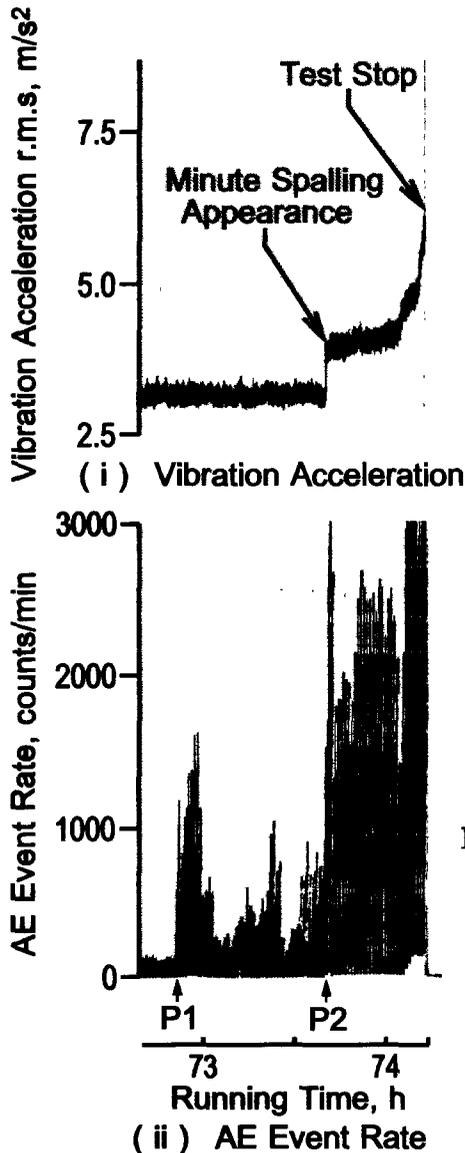
Figure 6 shows an example. In the case of the test bearing M-16 which was stopped at 74.3 h, there were certain trends in the vibration acceleration and the AE event rate. The X-axis indicates the running time in hours and the Y-axis is the r.m.s. value of the vibration acceleration in  $\text{m/s}^2$  and the AE event rate in counts/min, respectively. The r.m.s. value increased in a stage at the point of time P2 corresponding to 73.7 h in Fig. 6 (i), when a minute spalling appeared in the surface of the inner raceway. On the other hand, it could be seen in Fig. 6 (ii) that many AE were generated from the point of time P1 of 72.9 h before the spalling.

**Figure 6** Trend of Vibration Acceleration and AE of Test Bearing M-16

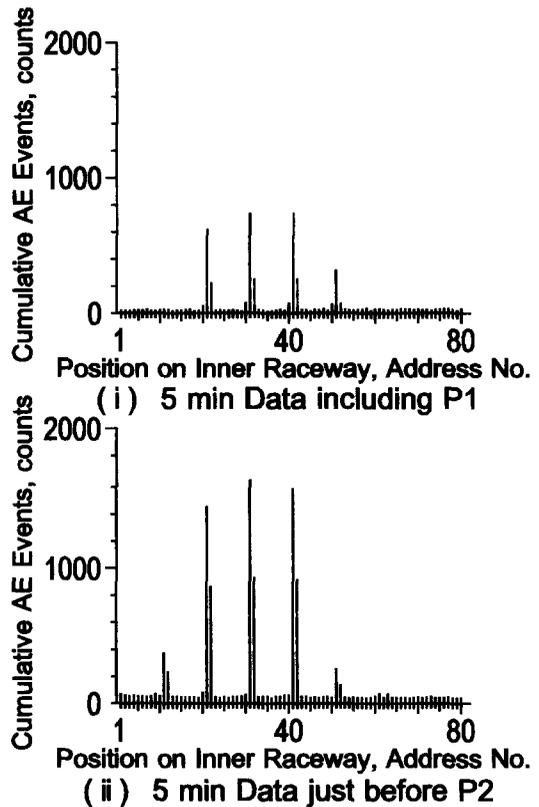
Figure 7 illustrates the location results of the AE source position on the inner raceway of M-16. All AE generated for 5 min including the time P1 and just before the time P2 were cumulated in the location results. The X-axis indicates the position on the inner raceway in an address scale from 1 to 80 and the Y-axis indicates the cumulative AE events in counts for 5 min. We can see in Fig. 7 that several peaks appeared at the interval of 10 addresses. The highest peak was at the address No. 31 on the inner raceway and the position of the highest peak was decided as the actual AE source position. The spalling position on the inner raceway was measured after fatigue test, and it was confirmed that the spalling position agreed with the located position. In addition, the same position was always located in the period from the time P1 to the time P2. Therefore, the AE detected in this period was presumed to be caused by the propagation of the rolling contact fatigue crack below the surface of the spalling position. Moreover, the time from P1 to P2 was 0.8 h, and it was considered that this time was equal to the propagating time of the fatigue crack.

**Figure 7** Location Results of Test Bearing M-16

The histogram in Fig. 7 (i) differed from the theoretical result as the located histogram was not symmetric about the highest peak. This difference suggested that the fatigue crack did not always propagate at every contact in the loading zone and propagated when the position of the crack came into contact with a ball before the maximum rolling element load position. Then, a few peaks appeared around each possible AE source position in Fig. 7. The reason for this was considered to be an error between a detected position and an actual contact position. The ball position was detected according to the outer surface of a cage in practice. Therefore, the error appeared due to the relative motion of the cage to the balls, because a clearance existed between the cage pockets and the balls.

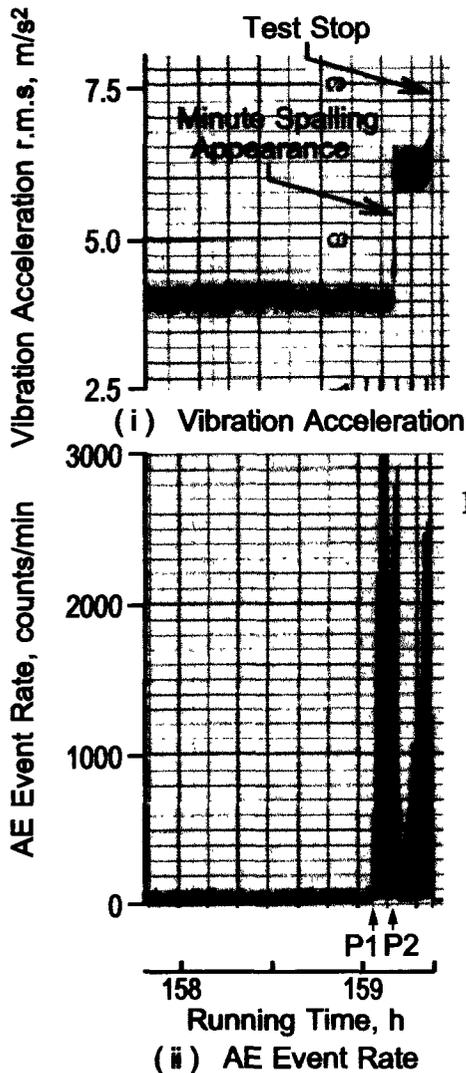
Figure 9 shows another example. In the case of the test bearing M-21 which was stopped at 159.5 h, there were certain trends in the vibration acceleration and the AE event rate. The r.m.s. value of the vibration acceleration increased stepwise at the point of time P2 corresponding to 159.2 h by the minute spalling appearance in Fig. 9 (i). On the other hand,

Figure 9 Trend of Vibration Acceleration and AE of Test Bearing M-21

it could be seen in Fig. 9 (ii) that many AE were generated from the point of time P1 of 159.0 h before the minute spalling appeared. Figure 10 illustrates the location result of the AE source position on the inner raceway of M-21 and all AE generated for 5 min including the time P1 were cumulated in it. The address No. 52 on the inner raceway was located as an actual AE source position by the histogram. It was confirmed that the located position agreed with the measured spalling position on the inner raceway accurately. Therefore, the time of 0.2 h from P1 to P2 was equal to the propagating time of the fatigue crack. Figure 11 shows the spalling at address No. 52 on the inner raceway.

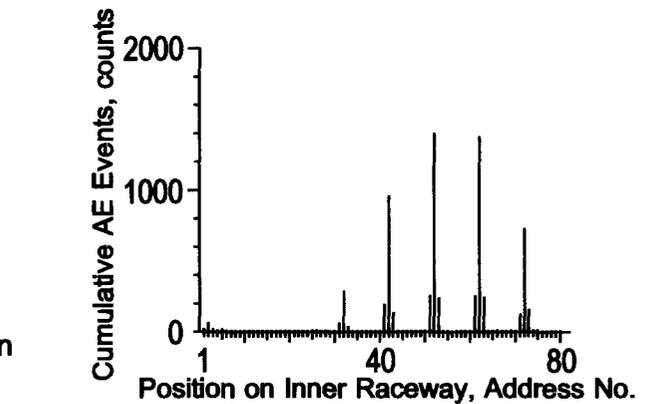
Figure 10 Location Result of Test Bearing M-21

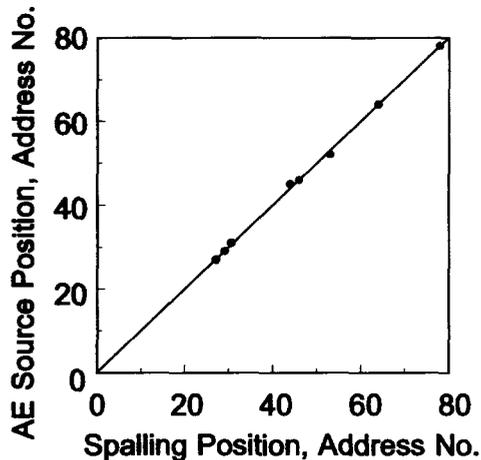
Figure 12 illustrates the relationship between the located address of the AE source position and the measured address of the spalling position in eight fatigue tests. The solid line of 45 degrees in Fig. 12 shows the correlation coefficient of 1. The plots obtained by the experiments are distributed near the solid line within the limits of  $\pm 1$  address. Accordingly, it was proven that the proposed method could locate the AE source position correctly, accurately and with good reproducibility.

**Figure 12 Relationship between AE Source Positions and Spalling Positions of Inner Ring**
