## FIFTH INTERNATIONAL CONGRESS ON SOUND AND VIBRATION

## DYNAMIC BEHAVIOUR OF AN AIRCRAFT POWER TAKE-OFF SHAFT DRIVE-SYSTEM

DSTO Aeronautical and Maritime Research Laboratory, Department of Defence, Australia

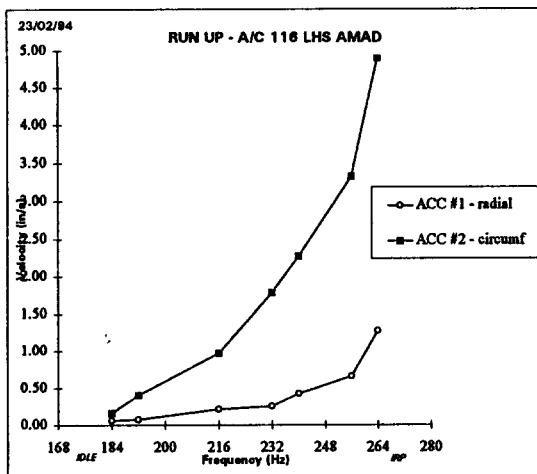
Figure 9 Left side 1X vibration

The initial measurements were made on an aircraft selected at random, using a tri-axial group of accelerometers on the PTS input bearing housing (Fig. 6) and an additional point on the base of the gearbox. The vibration frequency vs amplitude (in/s rms) for the three accelerometers is given in Fig. 8(a)-(c). The vibration amplitude (in/s rms) of the once/per revolution frequency component is plotted vs speed in Fig. 9 for the left-side, and Fig. 10 for the right-side.

The vibration levels recorded during this initial trial were exceptionally high, reaching 5.0 in/s rms (Fig. 9), and were much greater than considered acceptable for this class of machinery. Levels tolerated in aircraft tend to be higher than that considered acceptable for industrial equipment, however a level of 1.5 in/s peak velocity is generally considered to be an upper limit. For example, levels for the GE F-404 engine over 1.0 in/s average, (which is equivalent to 1.57 in/s peak) are considered an upper limit. The input housing vibration was predominantly once-per-revolution, almost certainly caused by a large unbalance in the rotating assembly. Misalignment could conceivably be a factor, but in view of the absence of large vibration at twice/rev, and the absence of a large axial component, it is not likely. Also, checks of the alignment of this assembly showed it to be within tolerance.

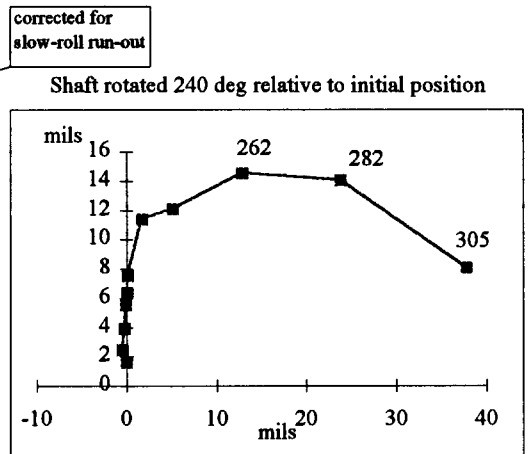
The AMAD gearbox post-overhaul test stand was utilised to carry out further tests on the drive system dynamic behaviour. Test results of drive-shaft radial amplitude are summarised in Fig. 13. The Nyquist plot (amplitude vs phase) shows a large increase in amplitude at the higher speeds, together with the phase change (lag) of vibration relative to the tachometer signal, which indicates that critical speed is not far beyond the 18000 rpm reached in testing.

Figure 13 Nyquist plot of drive shaft dynamic response on post-overhaul test stand
