A CASE STUDY OF DAMAGE EFFECTS TO RESIDENTIAL BUILDINGS CAUSED BY VIBRATORY COMPACTION EQUIPMENT

This paper presents the findings into a study of vibration magnitude versus potential damage caused by vibratory compaction equipment at two residential properties located in South Australia. The two residential properties under investigation are classified as ‘Contributory’ in the local Historic Conservation Policy Area by Council and were constructed between the late 1800’s and early 1900’s. Vibratory compaction equipment was operated near to the properties at varying distances and machine settings with the primary objective to relate the measured vibration magnitude to cosmetic or structural damage, and to compare the results to the German Standard DIN 4150-3, 1999, *Structural vibration – Part 3: Effects of vibration on structures*. The secondary objective was to relate the measured vibration magnitude to subjective human perception and other observed ancillary effects to assist with community consultation activities that occur as part of major infrastructure projects. The results from the two objectives are presented and discussed in this paper.

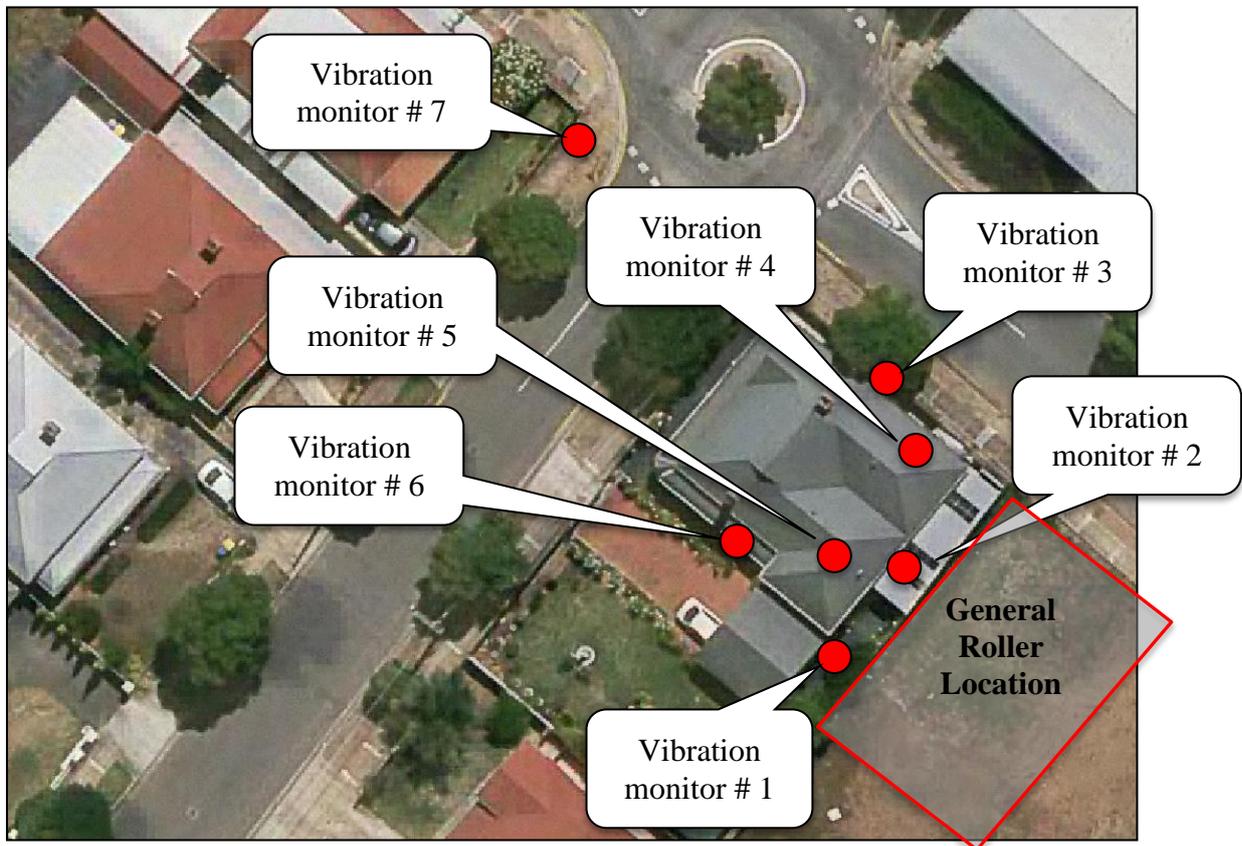
Figure 1. Monitoring locations – 47 Elizabeth Street

Calibrated AvaTrace M60 vibration monitoring loggers were utilised for testing. Vibration monitoring was carried out at the locations described in Table 1 and shown in Figure 1. Five roller locations were tested, namely 13m, 8m, 5m, 2m and 0m from the nearest point of the roller to the rear facade of the dwelling. The roller was generally stationary for tests.

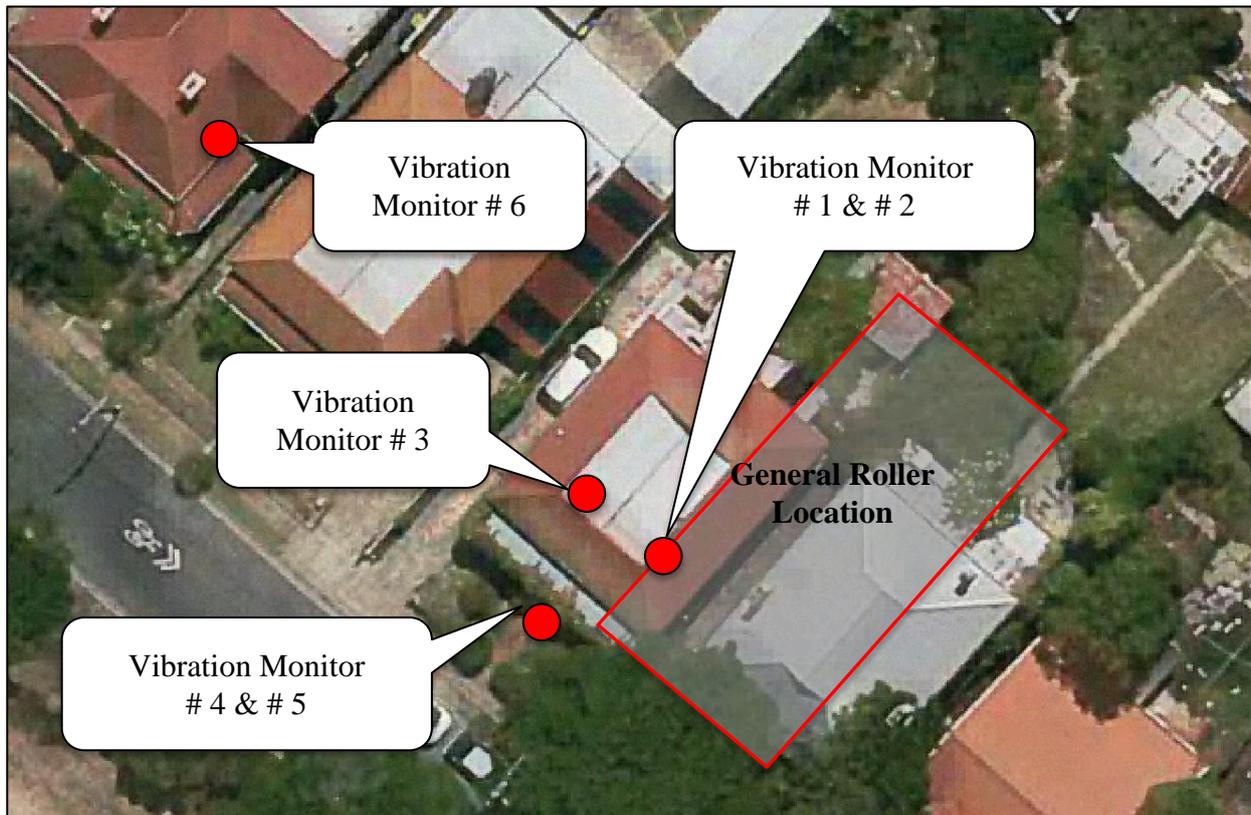
Figure 2. Monitoring locations – 4 Day Terrace

Vibration monitoring was carried out at the locations described in Table 2 and shown in Figure 2. Note that the two dwellings to the east of the property had been demolished, which allowed an operating area for the padfoot roller. A number of various roller locations and operating directions were tested, as summarised in Table 4. Note that the padfoot roller was unable to oscillate the drum in a stationary position and therefore was required to move forward and backward at a specific distance for the tests.

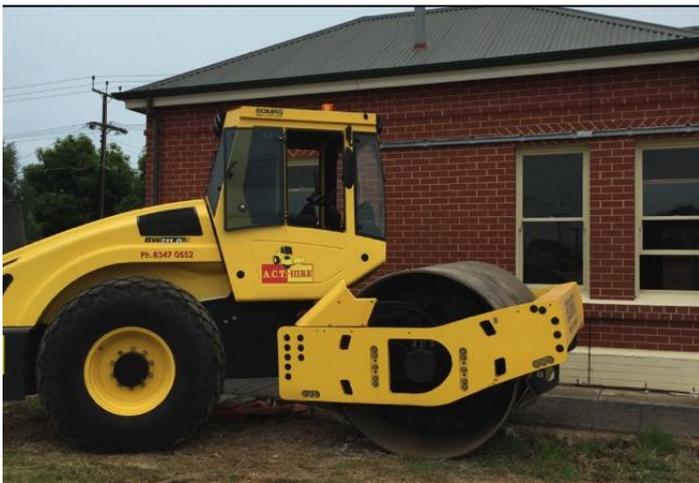
Figure 5. Roller at 2m

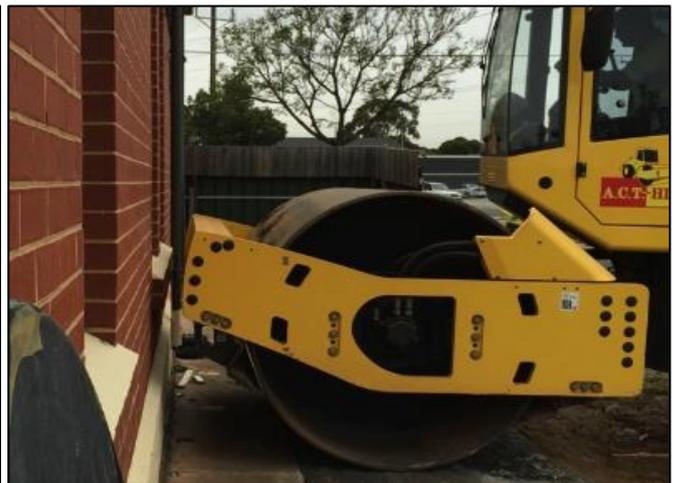
Figure 6. Roller at wall
