# Detection of Failed Conveyor Rollers Using an Acoustic Imager

Remi Hart (1, 2), Antonio Morais (2), Dave Matthews (1), Jie Pan (1)

(2) Alcoa Australia

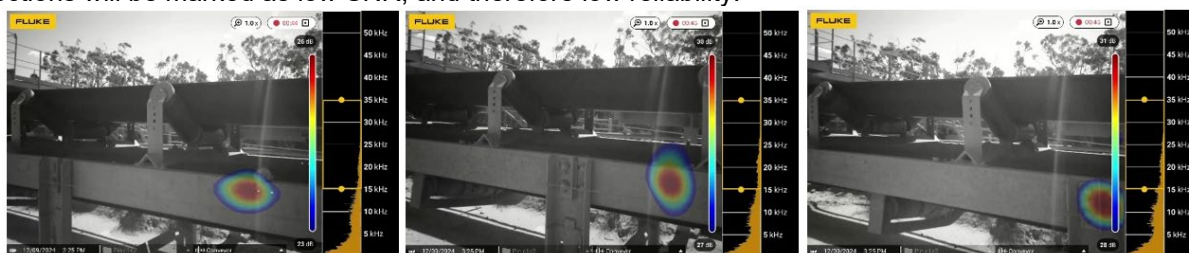
Figure 9: series of Acoustic images showing Motion of reflection relative to conveyor

Due to the high frequencies being used, it is accepted that reflection of sound off other environmental sources is possible. This has been empirically observed during testing as shown in Figure 9, confirming this behavior. Although reflections are present, the motion of the imager ensures they move relative to the reflecting surface as shown. As a result, these will only fall within the bounding box of the roller for some frames, and as such do not significantly contribute to the sound power levels being reported. In addition to the limited contribution to reported levels, the reflection will contribute to the noise used for calculating the SNR and as a result, an image with high reflections will be marked as low SNR, and therefore low reliability.
