Wayside horn noise investigation

Simon Moore

AECOM, Level 28, 91 King William Road, Adelaide, Australia

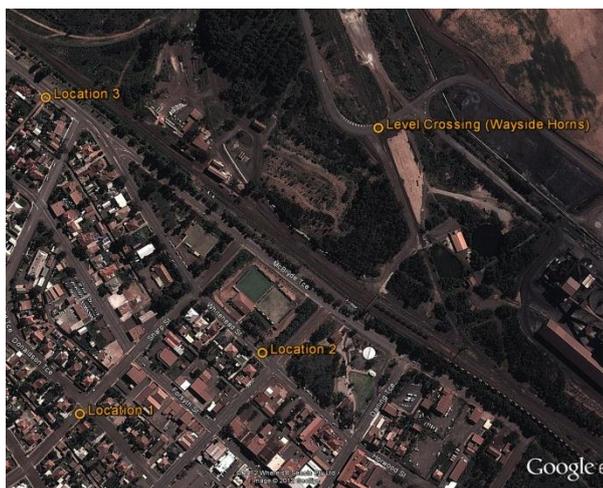
Figure 1. Level crossing and sensitive receiver locations

The level crossing is located on the OneSteel site on the Pellet Plant to Blast Furnace train line, as shown in Figure 1. The nearest noise sensitive receivers to the level crossing site are located approximately 400 metres to the south-east.

Maximum noise levels due to the wayside horns were measured at three locations in the residential area located to the south of the site. Measurements were undertaken under two wind conditions from separate visits.

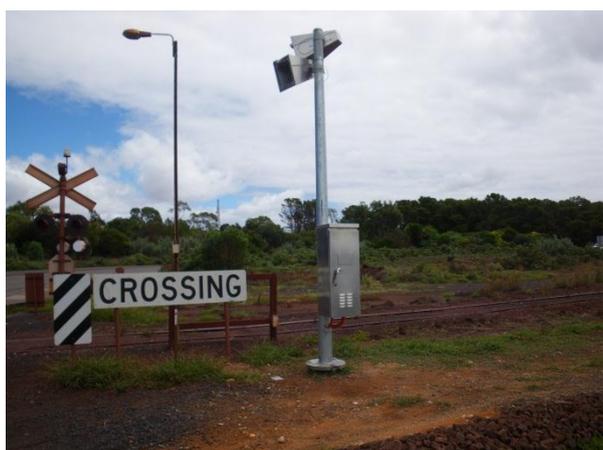
Figure 2. Wayside horn installation

Two wayside horns have been installed permanently on the north-eastern side of the crossing. The horns are mounted at approximately 4–5 metres above ground level and are oriented towards the hold line points on the western and eastern sides of the crossing. An image of the wayside horn installation is provided in Figure 2.
